FRACTURES OF BEAM-TO-COLUMN WEB
MOMENT CONNECTIONS

George C. Driscoll

Fritz Engineering Laboratory
Lehigh University
Bethlehem, Pennsylvania

March 1979

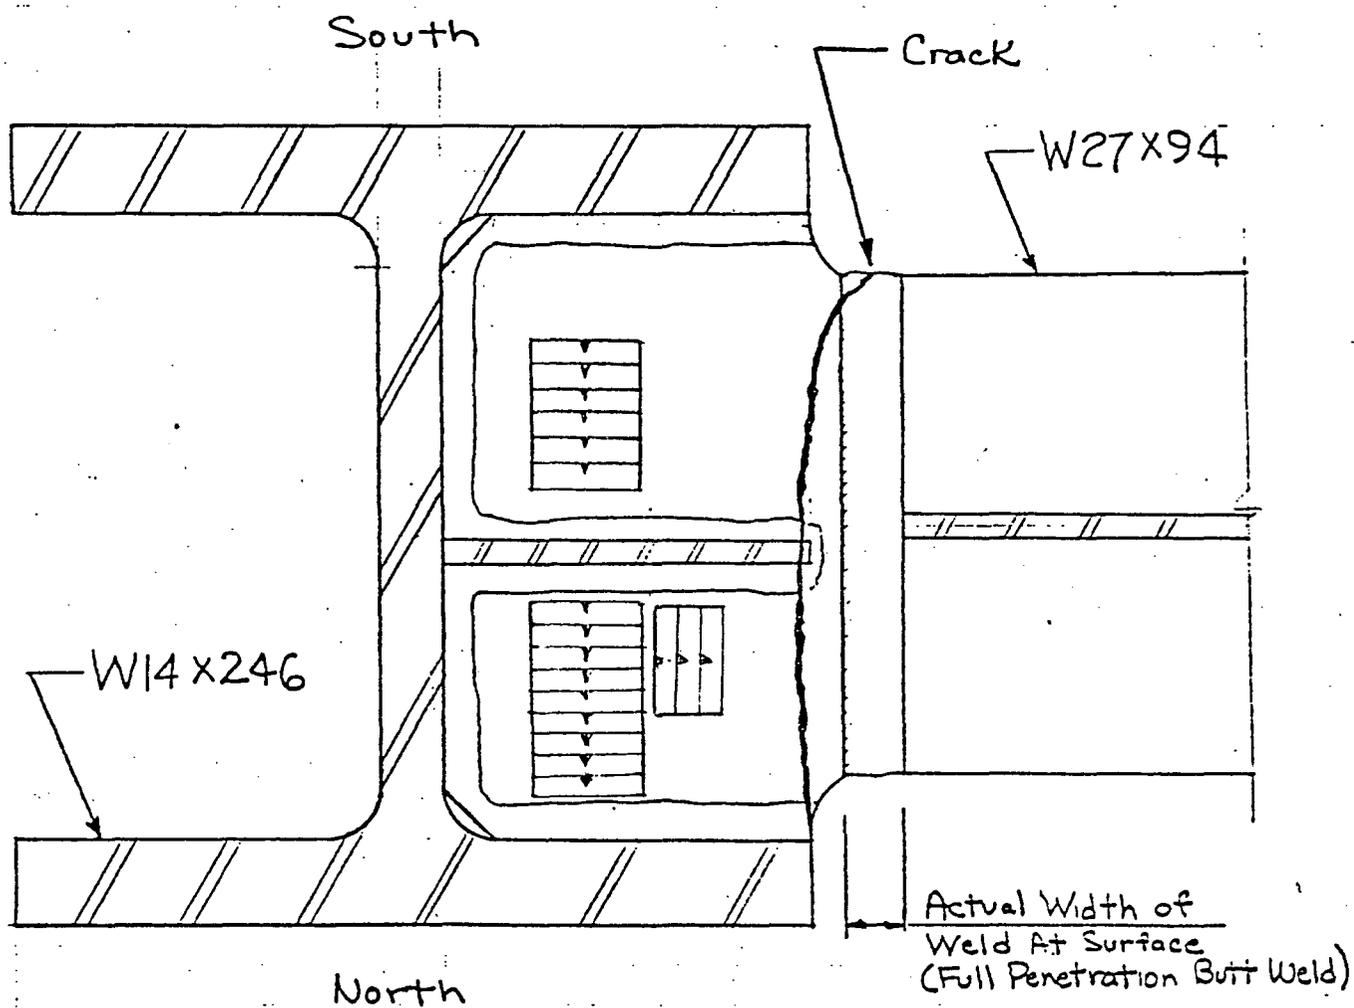
Fig. 3 Failure Location in Test 14-1

Figure 3 shows the location and extent of the crack which occurred during the connection test. Also shown is a smooth radius gratuitously formed by the fabricator in the connection plate between the point where the column flange ends and the beam flange begins. This detail may be compared with the squared off connection plate backing bar and beam flange of Fig. 1.

The fracture of Connection 14-1 initiated at the edge of the butt weld joining the beam tension flange to the connection plate. The point of crack initiation is indicated by the point of the arrow labelled "crack" in Fig. 3. The metallurgist noted that this point would have a strain concentration due to the reduction in plate width at the end of the radius. He also noted that weld irregularities could have concentrated to the strain concentration. The fracture was predominantly brittle in nature although there is evidence of several crack arrests which indicates some ductility in the region. There is no evidence of defects on the fracture which could have contributed to the failure.

Metallographic examination of the weld indicated that defects (voids and fusion line cracks up to 1/10 inch in maximum dimension) were present. It was noted that these defects were not greater in size than what might be typically found in structural welds.

The metallurgist concluded that this connection failed in a brittle manner due to the large applied tensile strain which was concentrated at the design detail. The defects present in the weldment were not identified as the primary cause.

This fracture initiated at the edge of the weldment (on the beam flange of the connector, roughly parallel to the weldment (perpendicular to the applied strain). The initiation site appears to be at the edge of the weldment where the design detail created a strain concentration when the flange of the connector was reduced in width by a radius to join the narrower beam flange (also weld irregularities could have contributed to the strain concentration).

The fracture was predominately brittle in nature although there is evidence of several crack arrests which indicates some ductility in the region. There is no evidence of defects on the fracture which could have contributed to the failure.

Although some defects were present in the weldment, it is felt that this connection fractured in a brittle manner due to the large applied tensile strain which was concentrated at the design detail.

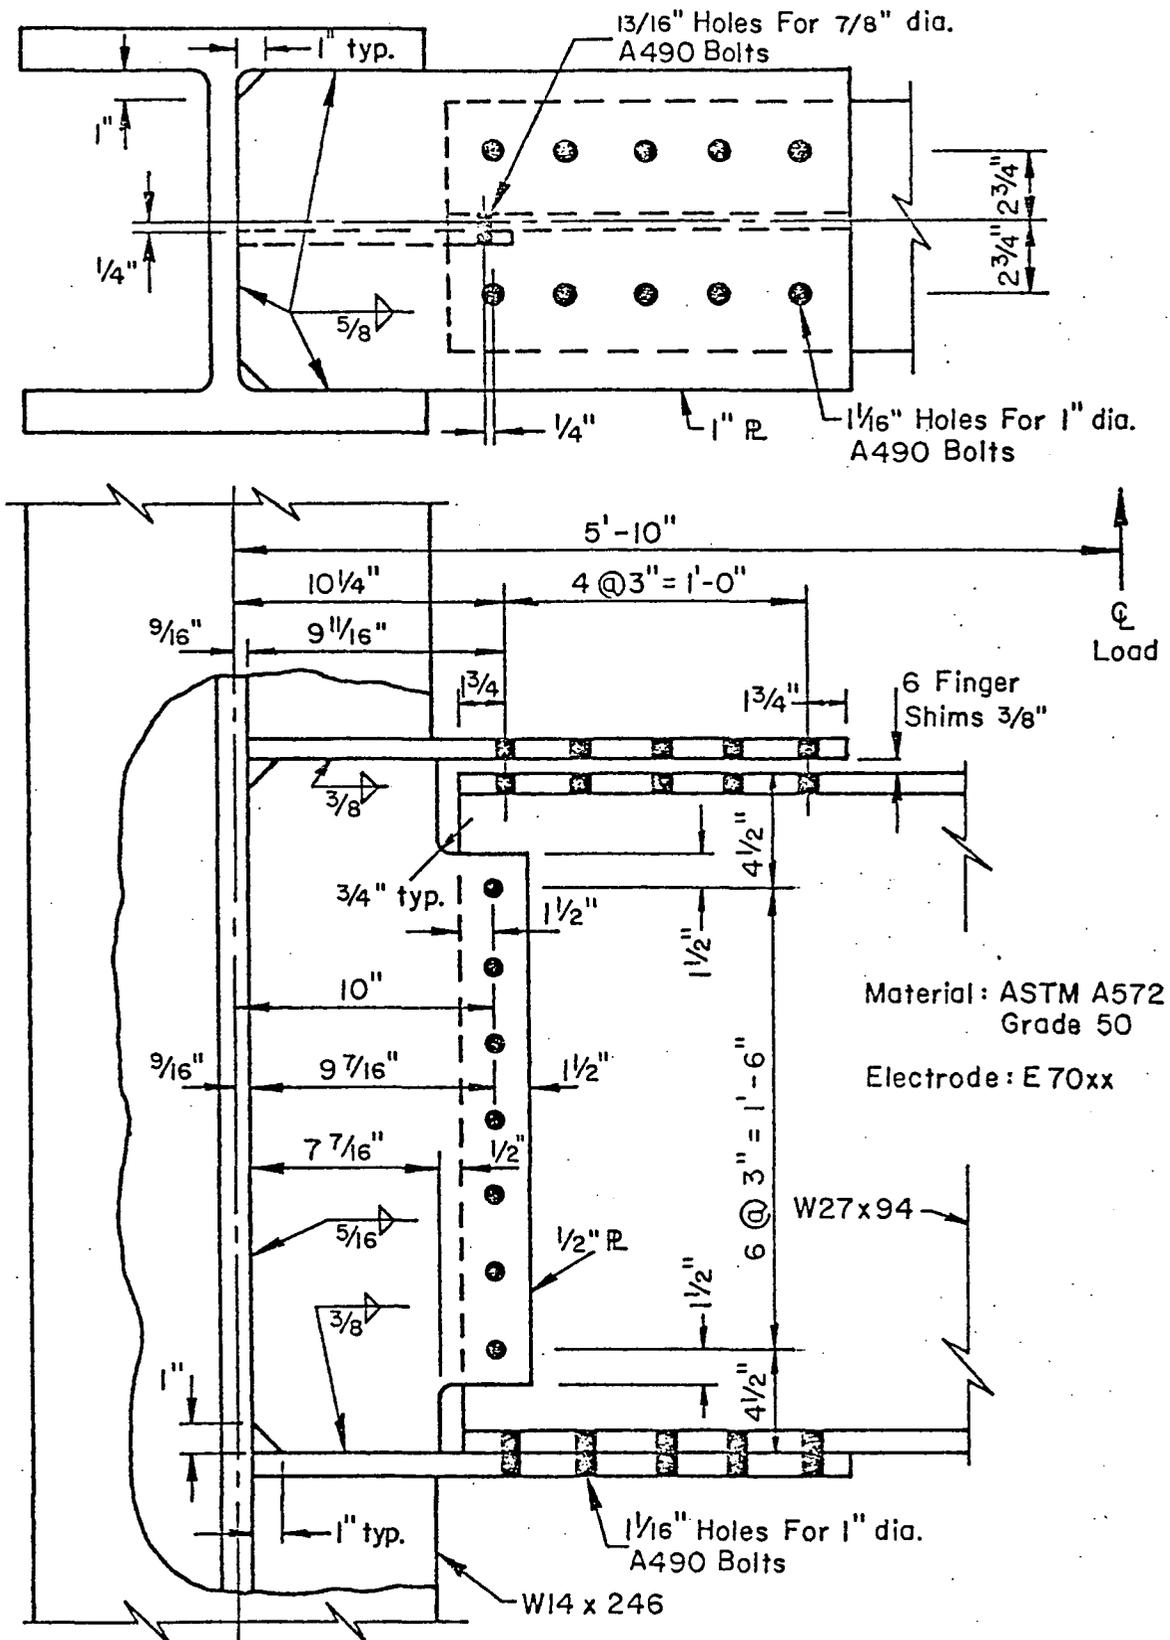
Fig. 4 Details of Connection 14-3

Fabrication details of connection 14-3 are given in Fig. 4. This connection was planned for field bolting of both flanges and web of the beam to flange plates and web plates shop welded to the column.

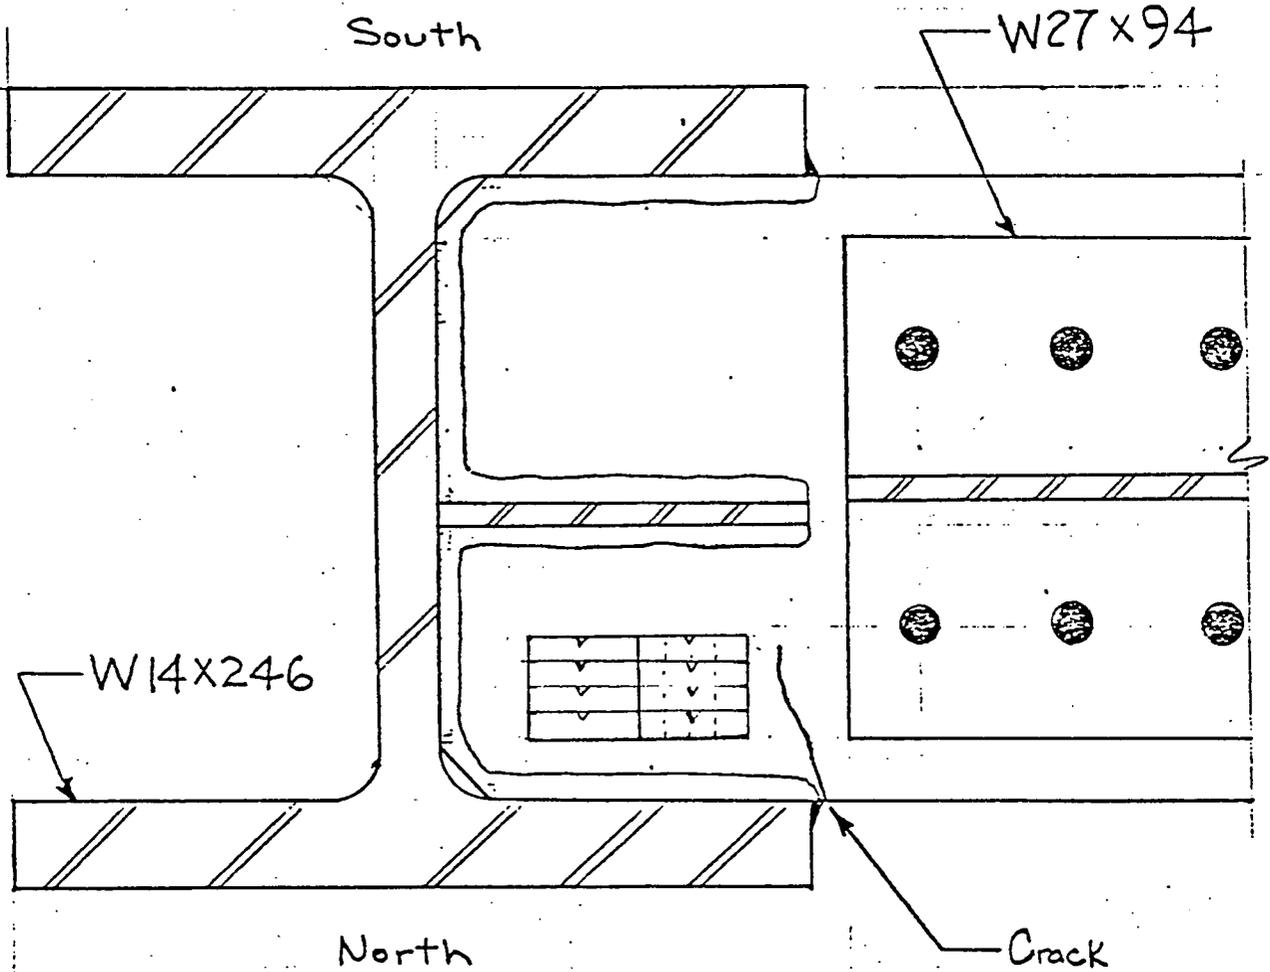
Fig. 6 Failure Location of Test 14-3

The path of the failure crack is plotted in Fig. 6. The figure also shows the location of cosmetic weld passes provided along the thickness of the connection plate at the tips of the column flanges.

The fracture of Connection 14-3 initiated at the end of the welding joining the tension flange connection plate to the column flange. The fracture propagated across the tension plate normal to the applied tensile strain. The initiation site appears to be at a cosmetic welding pass between the edge of the column flange and the side of the connection plate. The point of crack initiation is indicated by the arrow labelled "crack" in Fig. 6. The fracture was predominantly brittle, but shear lips are present indicating some ductility in the connection plate. There is no evidence of any defects on the fracture surface. (Note: The "cosmetic welding pass" might also be called a seal weld.)

The metallurgist concluded that Connection 14-3 failed when a large amount of strain was applied and was concentrated at a design detail (the edge of the column flange and tension plate) which was made worse by the use of a cosmetic edge welding pass.

This fracture initiated at the end of the connector tensile flange where it was welded to the flange of the column and propagated across the tensile flange of the connector normal to the applied tensile strain. The initiation site appears to be at a cosmetic welding pass between the edge of the column flange and the side of the connector plate.

The fracture was predominately brittle, but shear lips are present indicating some ductility in the connector tensile flange. There is no evidence of any defects on the fracture surface. The composition of the connector flange was not within the limits of ASTM A572 Grade 50 but meets the requirements of ASTM A588B (see Table 1). The hardness of this flange is HRB-84. The rolling direction of the connector flange was normal to the applied strain, so that the applied strain was in the transverse direction of the plate.

This connector appears to have failed when a large amount of strain was applied and the strain was concentrated at a design detail (the edge of the column flange and the connector flange) which was made worse by the use of a cosmetic edge welding pass.

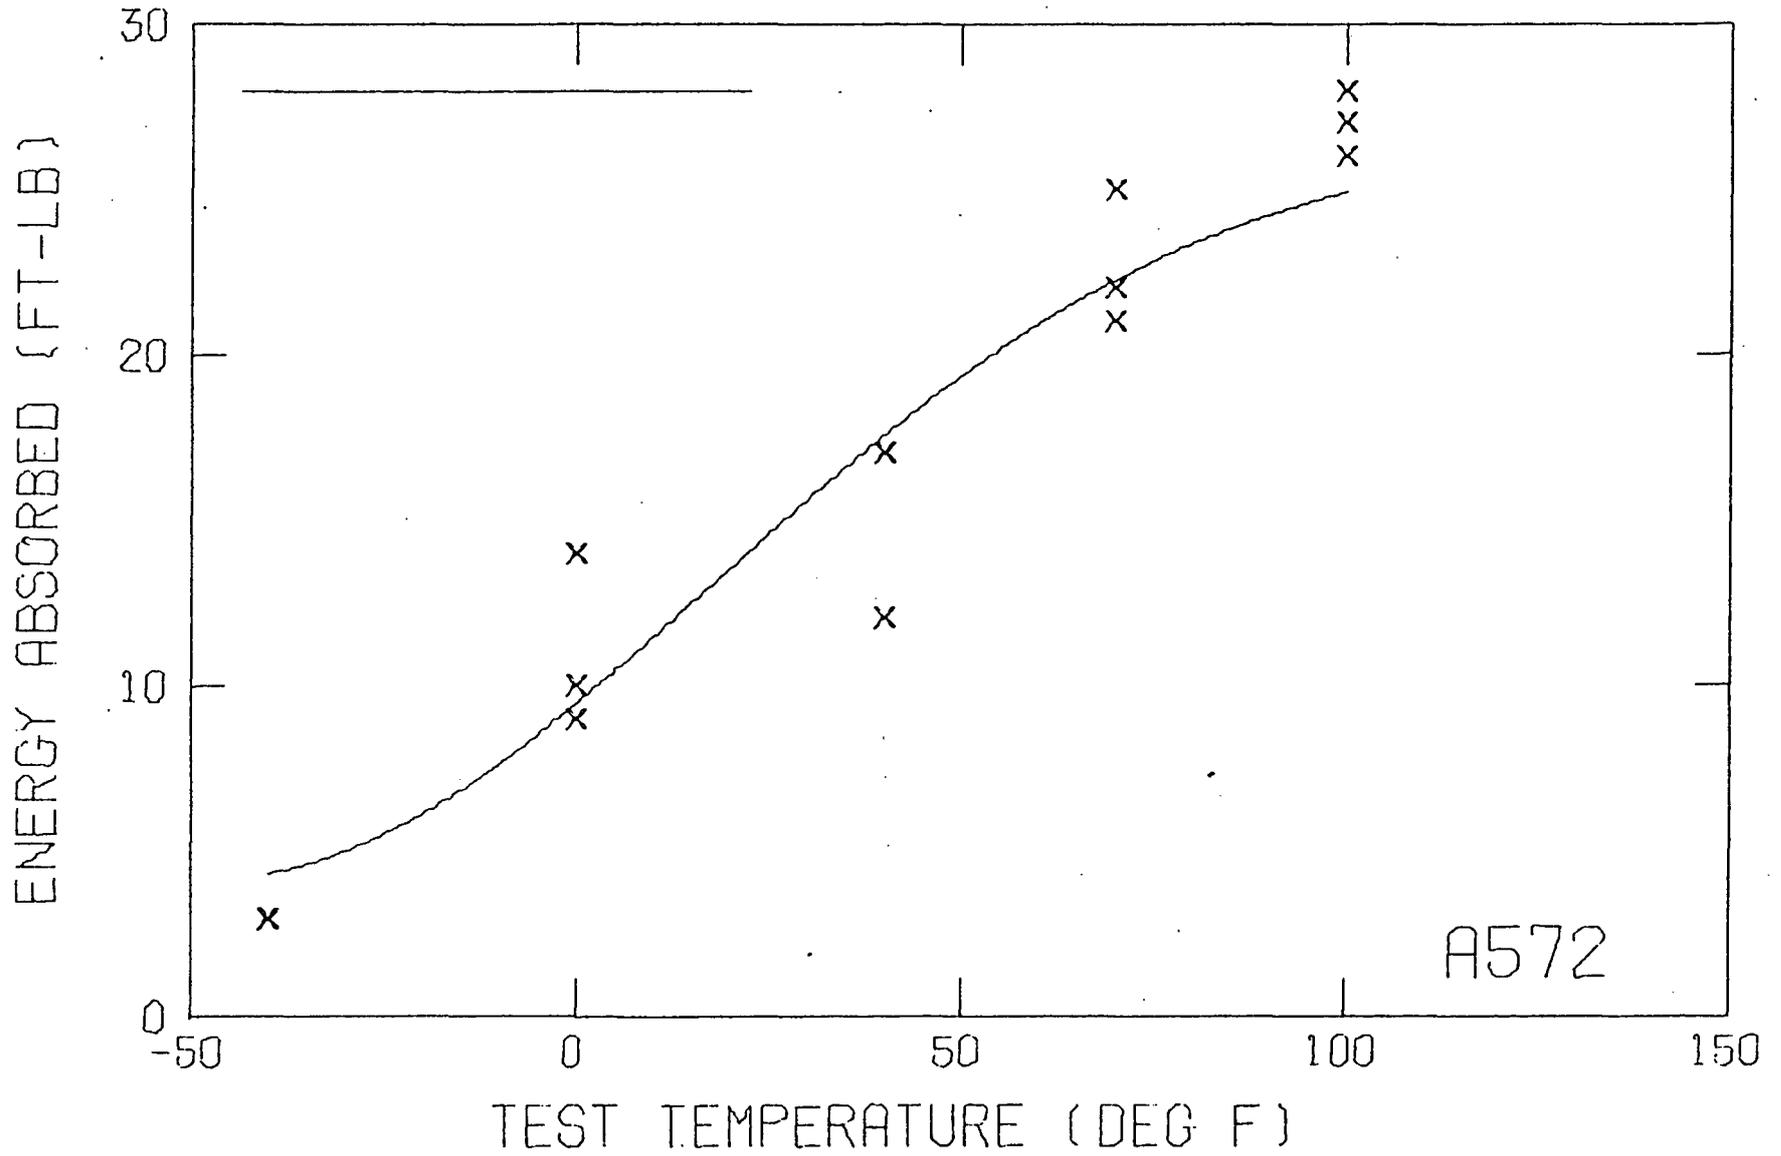
Fig. 7 Charpy Test Results for Connection 14-1

The fifteen TL specimens of Connection 14-1 were tested as planned, 3 each at temperatures of -40°F , 0 , $+40$, $+70$, and $+100$. Since 40°F appeared to be the temperature at which 15 ft-lb of energy was absorbed, the three LT specimens were tested at $+40^{\circ}\text{F}$. The test results were evaluated using a Metallurgy Department computer program which averages, curve fits, and plots the results. The resulting plot is given in Fig. 7 and the numerical results are given in Table 1. Based on an impact energy criterion, the steel was able to absorb 15 ft-lb at a temperature of 27.0°F . This is better than the AASHTO fracture-toughness specifications for A572 steel to be used in Zone 2 with minimum service temperature from -1 to -30°F (15 ft-lb at 40 F).

The three LT specimens for Connection 14-1 were expected to be better and they were. They gave values of 36, 19, and 39 ft-lb at 40°F , for an average of 31 ft-lb (see Table 3).

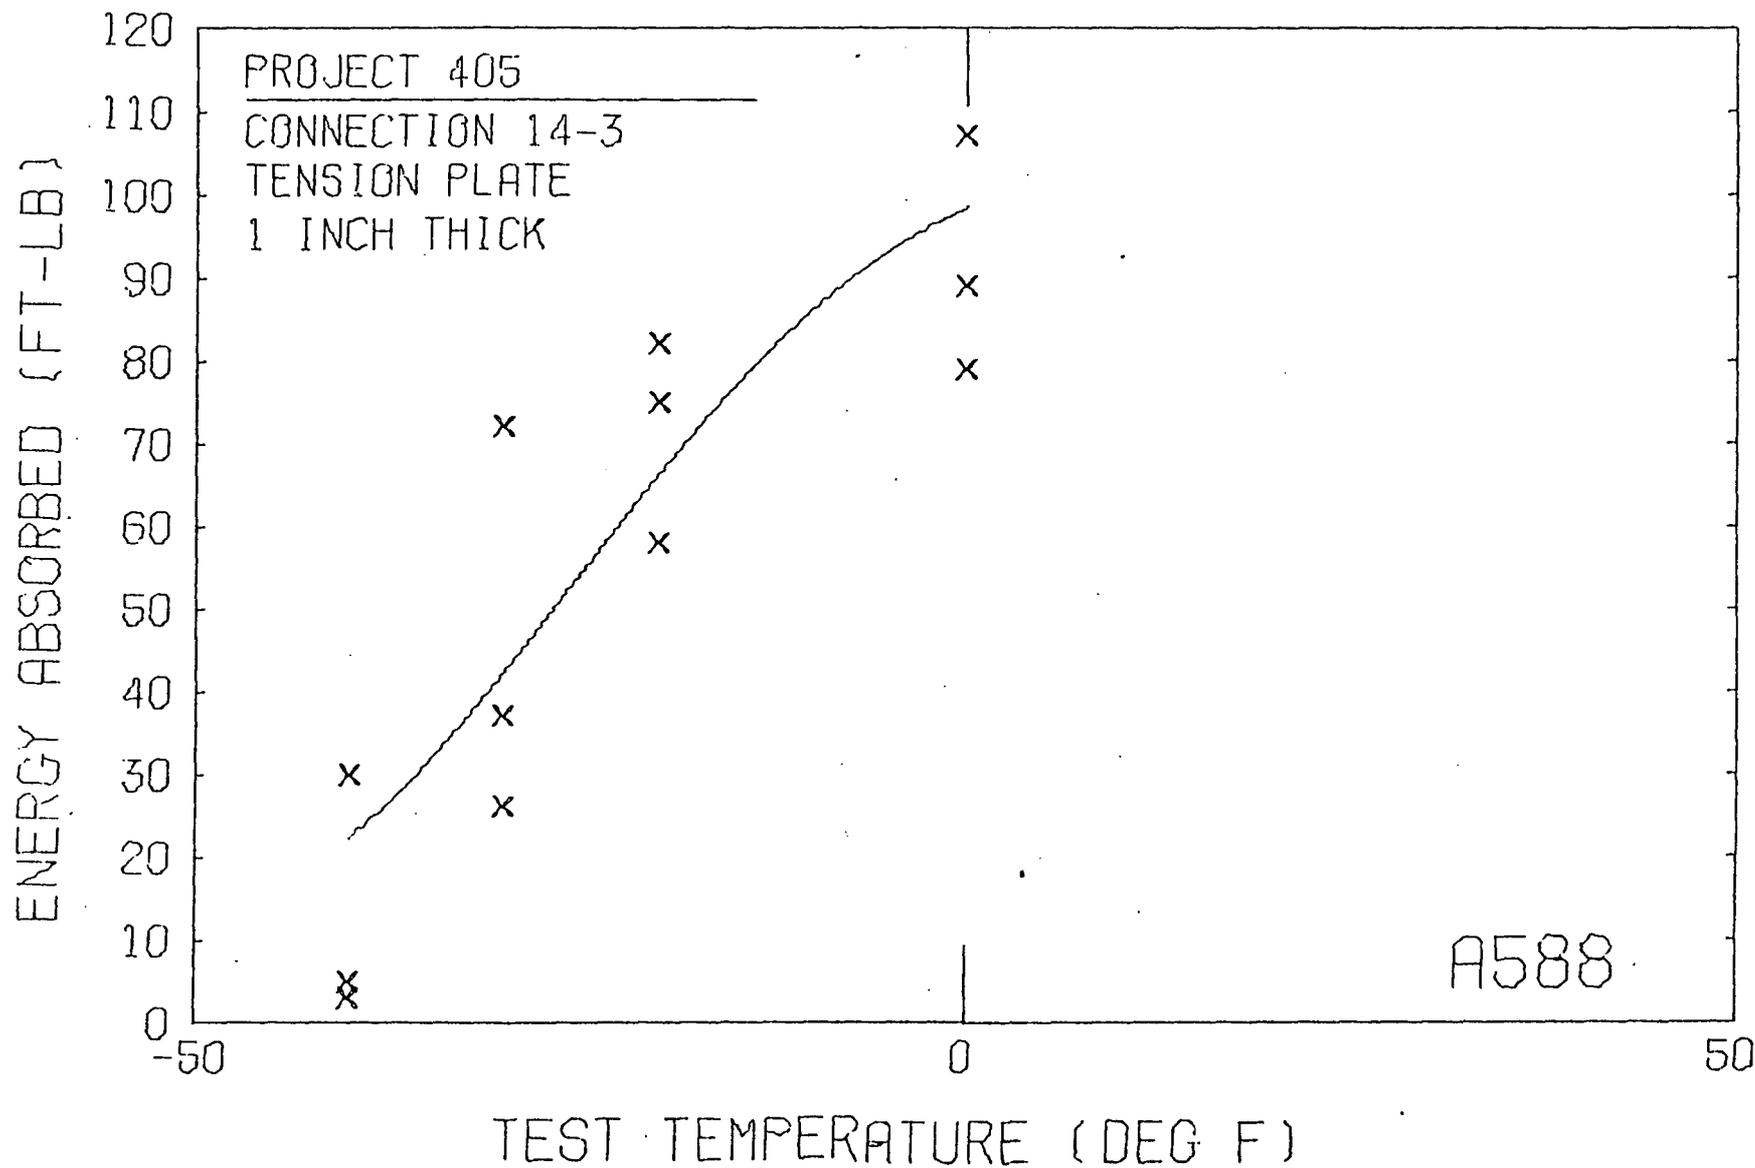
Fig. 8 Charpy Test Results for Connection 14-3

Testing of the Charpy specimens from Connection 14-3 required a different series of temperatures. The first three TL specimens were tested at 0°F and gave results averaging 94 ft-lb. Therefore the next three were tested at

-40 F resulting in values averaging less than 15 ft-lb. Henceforth, three specimens were tested at -30°F and three at -20°F . The test results are plotted in Fig. 8 and the numerical results are given in Table 2. Based on the impact energy criterion, the steel was able to absorb 16 ft-lb at a temperature of -49°F . This is better than the AASHTO fracture toughness specifications for A588 steel to be used under the most severe Zone 3 requirements with minimum service temperature from -31 to -60°F (15 ft-lb at 10°F).

The three LT specimens for Connection 14-3 gave values of 14, 10, and 12 ft-lb at -30°F (see Table 3). These values were lower than the values of the perpendicular specimens at the same temperature. These results are adequate compared to the A572 steel, although they place suspicion on the accuracy of determination of the rolling direction. The metallurgists had indicated that they were not absolutely sure of the rolling direction for this one specimen.
