# Non-destructive testing of foil pouches. Determining a reliable method for checking for punctures

Clifford Allen Dey  
*Lehigh University*

A Thesis

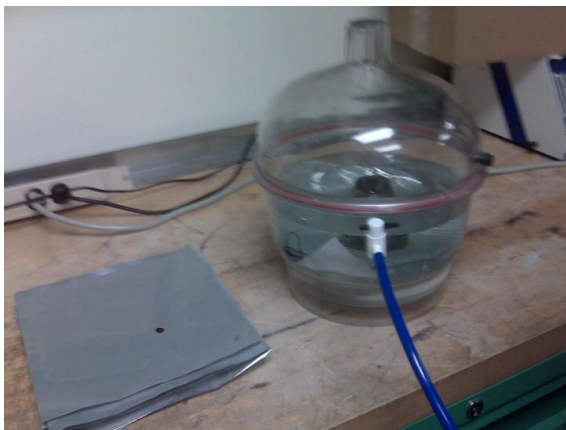
**Figure 3 Bubble Leak Test Station**

This test is outlined in the American Society for Testing and Materials (ASTM) Test Method F 2096 [1]. This test is performed by submerging the pouch in a liquid (usually water) and pulling a vacuum on the system. If a puncture exists then air will escape from the interior of the pouch through the puncture and form bubbles. This could be considered a destructive test because of the submersion in a liquid. See Figure 2 for a typical bubble leak test set up. Each pouch would have a known size precision hole attached to it. The pouch is the place in a clear glass “bowl” and weights are placed on top of it to keep it submerged while a vacuum is pulled, see Figure 3. The top is then placed on the bowl and a vacuum is pulled creating a pressure differential between the inside of the pouch and the interior of the “jar”. Pouches with 12.5  $\mu\text{m}$  and 25.0  $\mu\text{m}$  precision holes attached were tested and no bubbles were observed however pouches with 50  $\mu\text{m}$  holes did produce bubbles. This test is not acceptable at this time based on problem statement of non destructive test.

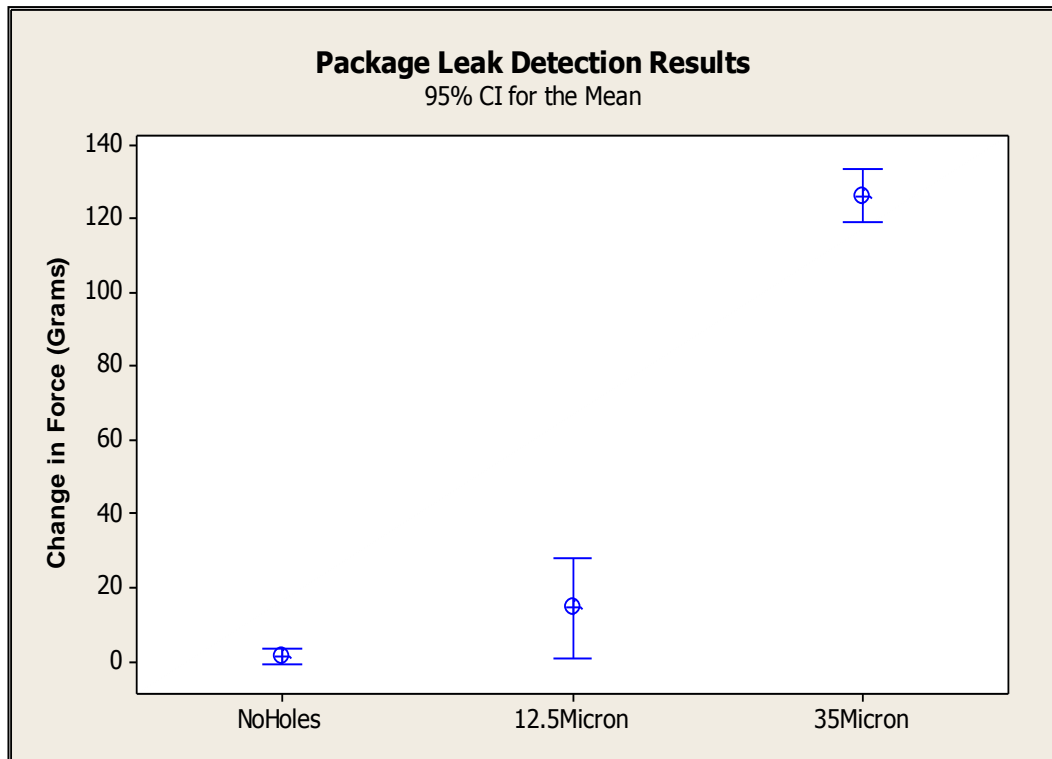
**Figure 5 Package Leak Detection Results Feasibility Run**

However the 12.5  $\mu\text{m}$  holes overlapped the zero hole results indicating that the reject decay value would need to be chosen so that in all probability “good” packages would be rejected, this would not meet six sigma standards for process capability.

The data for the 35  $\mu\text{m}$  holes was normal with a p-value = 0.008 using the non-parametric Anderson-Darling test. The other data sets are not normal with a p-value < 0.005 using the same non-parametric test. This data was also not normal using the non-parametric Kolmogorov-Smirnov test.

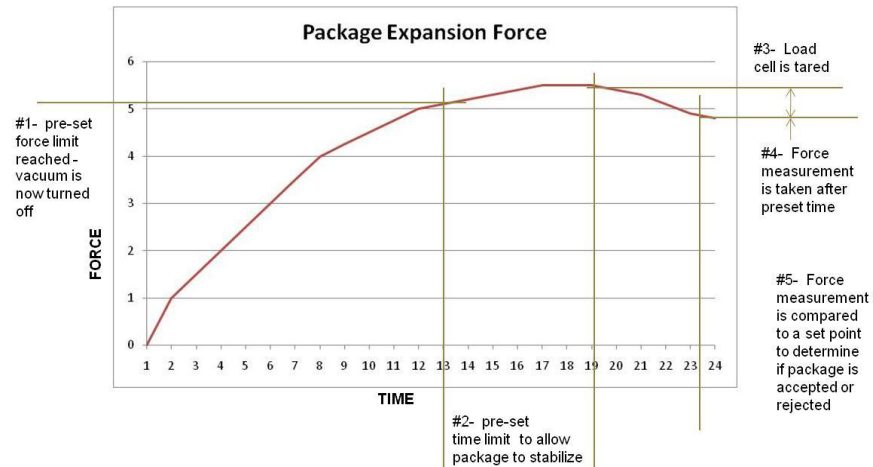
Figure 6 Graph Of Force Decay Test

This can be expected as the precision holes have a tolerance of  $\pm 10\%$  also the packages have variable headspace in them and this could affect the test. See Figure 7 to see how the test works.

The foil pouch was placed into the nest in the test chamber by the operator. The cover was closed and locked by the operator. Operator then pressed start button. The chamber then pulled a small vacuum, allowing the package to inflate due to the pressure difference between inside of package and the chamber. The package was then moved up via a servo motor until the force meter read 0.5 kg. Following step 5.3.5, the chamber pulled a vacuum until the force gage read 15kg. Note: If the machine did not register the required force within 60 seconds, the test was marked as a failure. The vacuum was then turned off and a 12.5 second settling time occurred. At the end of the 12.5 seconds, the force gage was read (Force 1). If the reading after the settling time was below 13 kg, the package was marked as a failure and rejected. After step 5.3.7 there was a six second measurement time and the force gage was read again (Force 2). That reading (Force 2) was then subtracted from the measurement at the end of the settling time (Force 1); the difference was the force decay value. This value is shown negative because it is the amount the force decreased. This value can be compared to a pre-determined decay set point. A value between 0 and the set point is marked as a pass. Note: A large puncture may receive a value like this, but it would have failed in a previous step due to the fact that with a large puncture the package will not inflate to apply force on the gage (as described in 5.3.6).

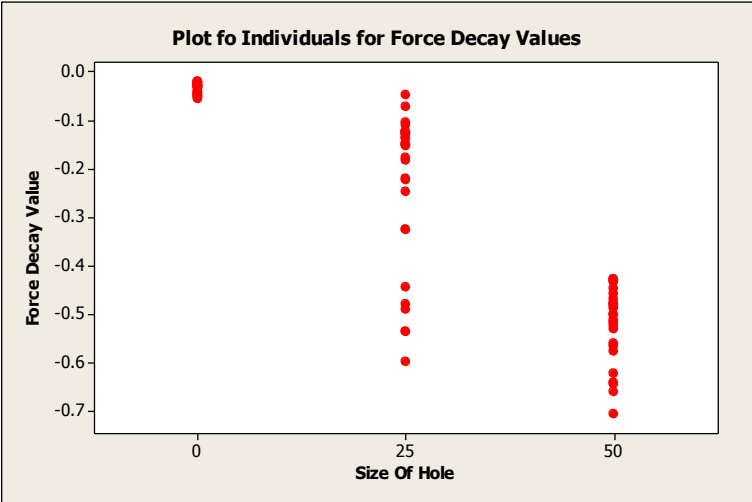
**Figure 7 Individuals Plot Of Force Decay Values**

See the Individuals Chart for the force decay values for the three groups in Figure 7 below.

There is one package (#56) in the 25 $\mu$ -hole group with a low force decay value that is a statistical outlier. There are five packages (#8, #13, #61, #62, and #78) in the 50 $\mu$ -hole group with low force decay values that were removed. After examining these packages it was determined that the decay values were due to packages not being prepared correctly and they were removed. The three distributions for force decay were compared in order to establish a possible force decay threshold value. The proposed decay threshold value was then established by taking the average value for the 0-hole packages and subtracting 5 standard deviations, resulting in a proposed threshold limit of -0.09. The five standard deviations was chosen to provide a factor of safety to prevent any good packages from being rejected. All 50 $\mu$ -hole packages had actual force decay values at least

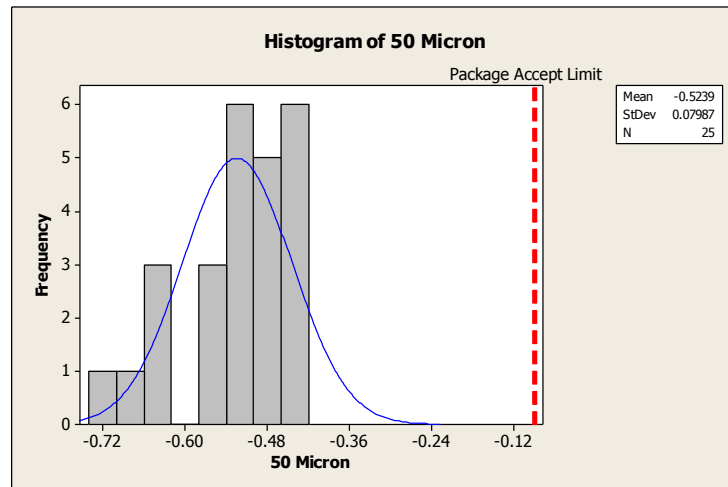
**Figure 8: Histogram Of The 50  $\mu$ m Decay Value**

4 times greater than -0.09 and thus can clearly be distinguished from the 0-hole packages. The proposed value allows essentially no overlap with the predicted distribution of 50 $\mu$ -hole decay values with the 0-hole (good packages) (see Figure 8).

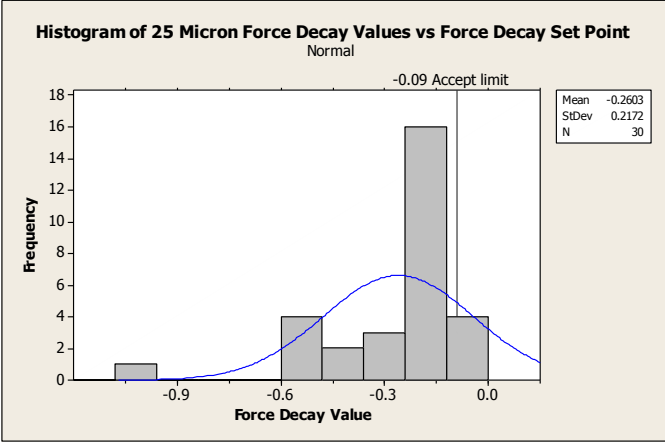
**Figure 9 Histogram Of 25  $\mu$ m Decay Values vs. Reject Value Set Point**

A similar graph comparing the distribution of force decay values for the 25 $\mu$ -hole group to the proposed force decay threshold is shown in Figure 9. Two 25 $\mu$ -hole packages (#51, #125) had force decay values that passed the proposed threshold value. Two other packages (#42 and #47) had decay values close to the proposed limit (-0.11 and -0.10, respectively). The graph also shows the negative skewness, potentially due to decay values associated with incorrectly-prepared packages. The area under the curve (to the right of) the -0.09 proposed threshold reflects the predicted false-accept rate for the 25 $\mu$ -hole packages using this data. An analysis estimates this rate at about 21%. Although this rate is overestimated by assuming a normal distribution in the calculation it is unacceptable. When the single high decay value (-1.05, #56) is removed the distribution is still negatively

skewed. Eliminating the skewed results by improving the variability of the 25 $\mu$ -hole packages to make the data normal this would reduce this rate. We could also move the set point to the right closer to the 0-hole packages possibility having some “acceptable” packages rejected.

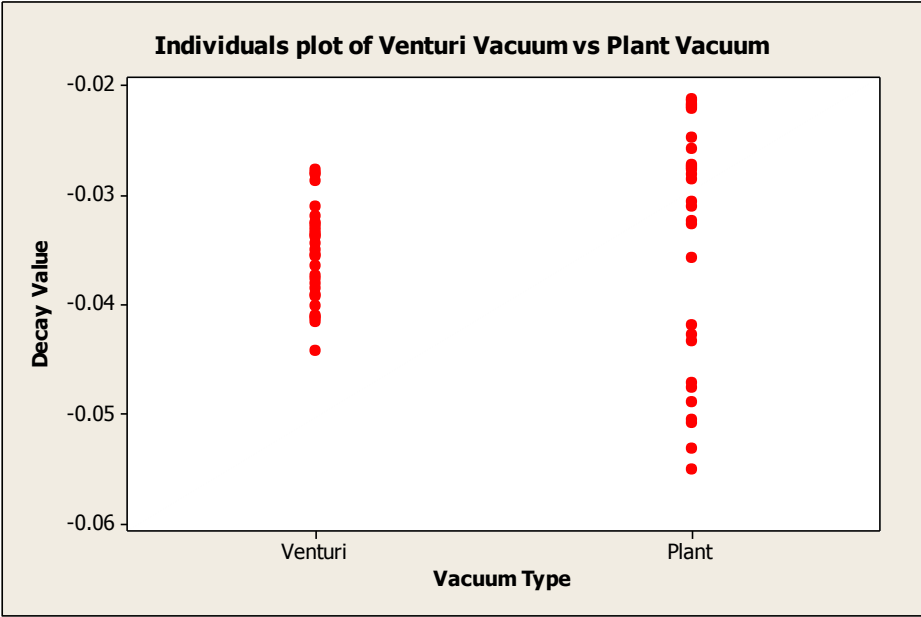
Figure 10 Plant Vacuum vs. Piab Source

This test was performed using plant vacuum. During the 0-hole run, one package (#195) failed to achieve the minimum force set point (15 kg) due to a failure of the plant vacuum. This could possibly cause the variability of the tests After experiencing this failure a venturi vacuum system was installed prior to running the next tests. The thirty 0-hole packages were tested again using the Piab system. An Individuals Plot for each condition is shown in Figure 10. The descriptive statistics for each condition are provided in Table 6. The consistent vacuum source reduced the standard deviation from 0.01117 to 0.004435. The data with the Venturi Vacuum passed the normality test (p-value: 0.559). In addition, the variance (standard deviation) was significantly less (p-value: 0.000).

Therefore it was determined this was the vacuum source that would be used for Part 2

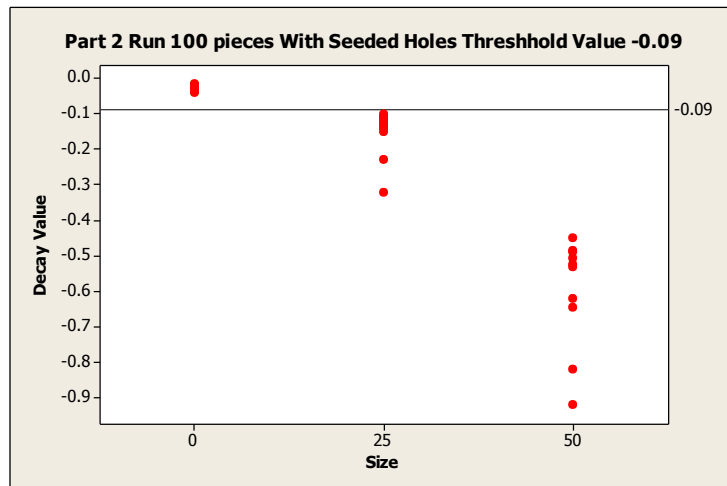
**Figure 15 Individuals Chart of 100 Piece Seeded Run**

The individuals chart in Figure 15 shows the results. There was one 25 $\mu$ -hole package (#33) that failed at the stabilization step so it was removed from the analysis in figure 15.

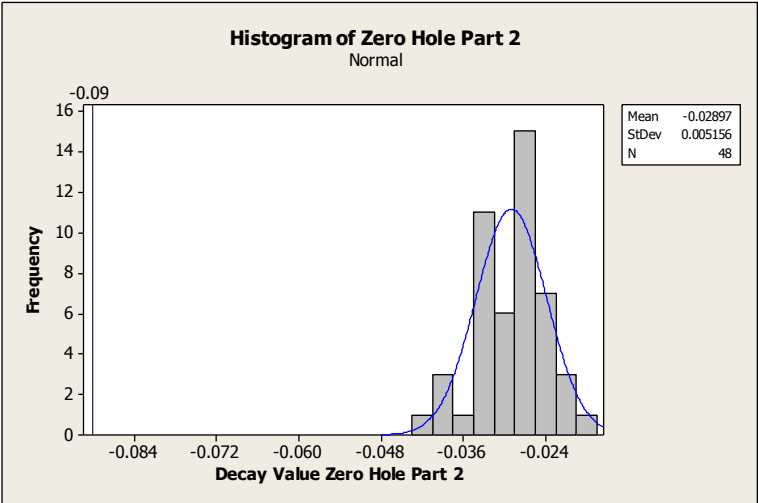
**Figure 16 Histogram of the Zero Hole Packages**

In Figure 16 a histogram of the pressure decay values is shown for the 0-hole packages. The distribution is normal (Anderson Darling Test P-Value = .559).

Figure 16 shows the variation in 0-hole decay values has been reduced from the results obtained in the first test. Given the reduction in the standard deviation of the pressure decay in the 0-hole packages, it looks like 0.09 threshold value is 12 standard deviations from the 0-hole average. This provides an opportunity to re-establish the pressure decay threshold value.

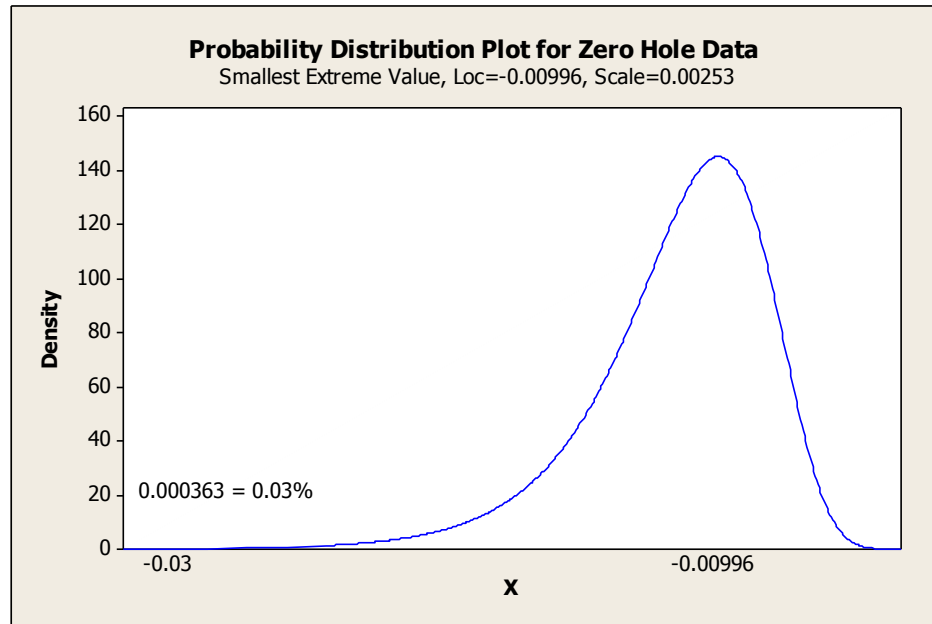
**Figure 17 Distribution Plot of Zero Hole Secondary Development Run**

Each population was assessed for normality, and the data set for 0-hole was normal Using the Kolmogorov-Smirnov test  $P = 0.028$ , however the 25µm and 50µm hole packages was not normal with a P-Value of  $<0.05$ . The separation of the 25 µm packages from the 0-hole packages was significant enough, a factor of 10, that further analysis of the 50µm data was not warranted. In order to calculate the threshold accept value for the integrity tester, the standard deviation of the zero hole packages (0.0037) was multiplied by 6 and subtracted from the mean of the zero hole packages. The six standard deviations was used to help minimize the possibility of acceptable packages being rejected causing a high loss rate or lower yield. This resulted in an accept value of -0.0337, which must be rounded to -0.03 to accommodate machine limitations. After rounding, the threshold value is 5 standard deviations from the mean. The 0-hole data set was analyzed to determine an appropriate distribution. The Gumbel Smallest Extreme Value type 1 distribution was used and is shown in figure 17. The density function is  $F(x) = 1/\sigma \exp(-z - \exp(-z))$ , where  $z = (x - \mu)/\sigma$ ,  $\mu$  is the location parameter and  $\sigma$  is the distribution scale

the distribution plot shows that only 0.03% of the zero hole packages will fail at or below the -0.03 Decay set point. This threshold decay value was then compared to the data set generated from the 25 $\mu$ m hole packages. The proposed threshold value (-0.03) is 3.8 standard deviations from the mean of the 25 $\mu$ m hole packages. However, further analysis of the 25 $\mu$ m data set indicated that the standard deviation was affected by two decay values below -0.200 (packages #605 and #601. These two outliers cause the standard deviation to more than double. The cause of each of these outliers was the precision hole not attached correctly at the interface between the adhesive attachment ring and foil, leading to pressure loss between the foil and the ring in addition to through the hole. ). Excluding these two points yields a standard deviation of 0.0115. The mean of the other 28 packages is -0.1247 and the distribution is normal with a Anderson-Darling test P-Value of 0.496. Using this data, the proposed threshold value (-

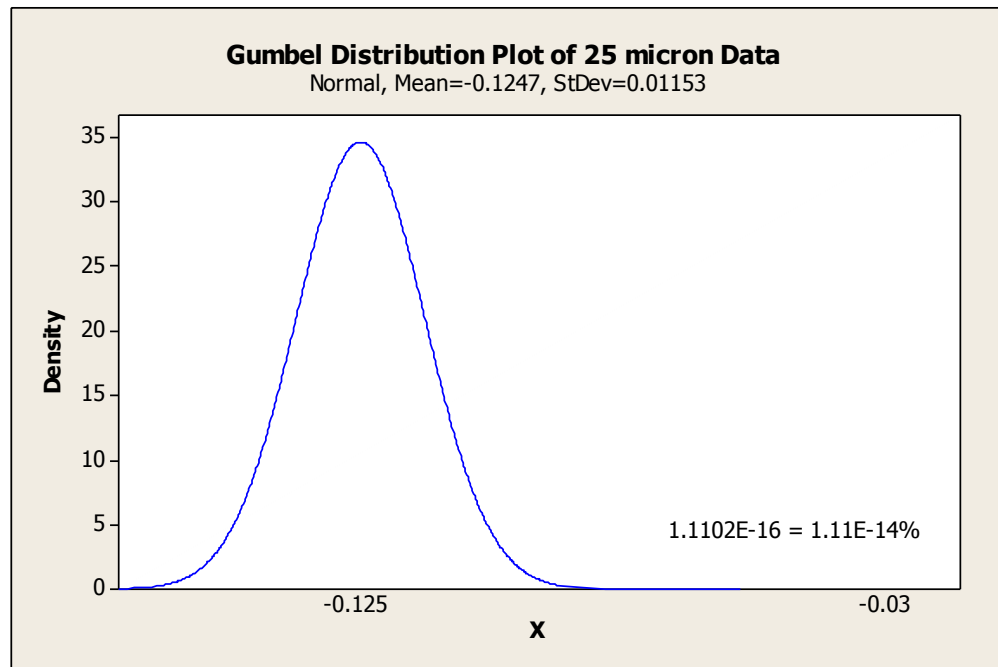
**Figure 18 Gumbel Distribution Plot of 25  $\mu$ m Holes**

0.03) is 8 standard deviations from the mean decay value. A probability plot (excluding the two outliers) shows the probability of a 25 $\mu$ m hole passing is  $1.11\text{E}^{-14}$  %. This is considered a more accurate reflection of the probability of a 25 $\mu$ m hole package passing the threshold decay value, as the excluded values were from the more negative side of the distribution.

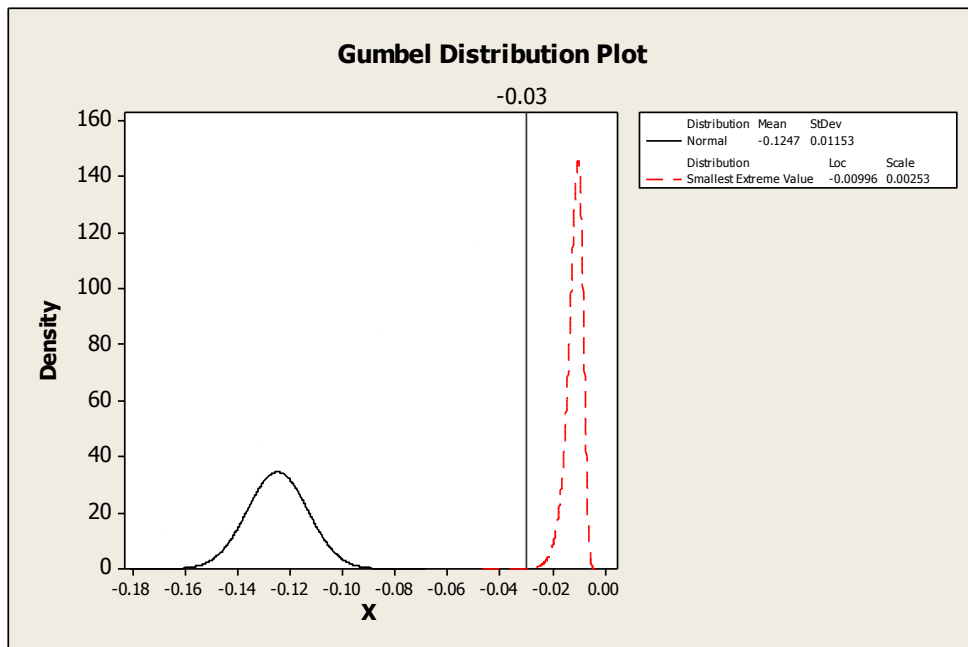
**Figure 19 Comparison Plot of the two populations versus Accept decay value**

The threshold decay value of -0.03 provides sufficient protection against packages with 25 $\mu$ m holes. The two populations can be seen relative to the Accept decay value of -0.03 in Figure 19 below.

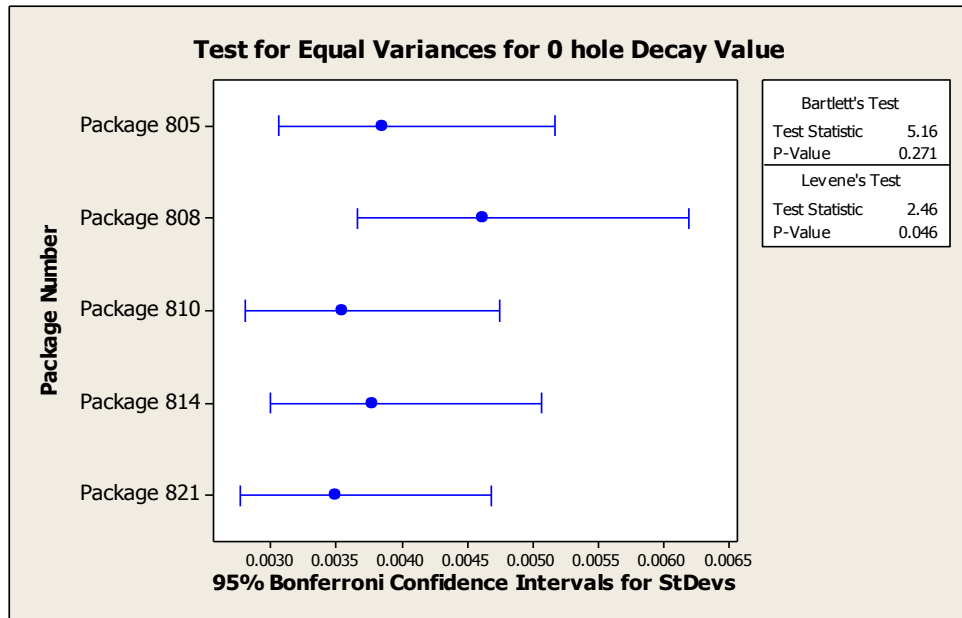
Figure 20 Test For Equal Variance of Repeat Testing of Zero Hole Packages

The test for equal variances in the zero-hole and 25  $\mu$ m data indicated statistically significant differences in variance ( $p=0.046$ ) and ( $p=0.000$ ), respectively, which prevented the data from being pooled. Individual/Moving Range Charts were used to evaluate overall trends for repeat testing of the 0-hole and 25 $\mu$ m packages. The charts are shown in Figures 20 and 21.

The Individual Value charts for both groups show the decay value is relatively stable for 50 repeat cycles. The most variable zero hole data has a range control

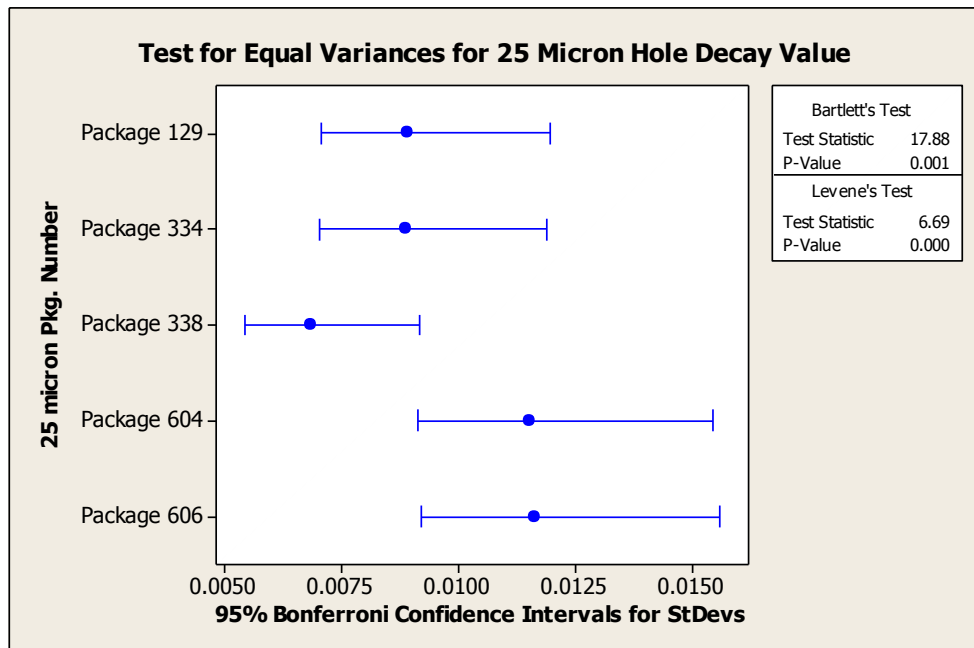
Figure 21 Test For Equal Variance of Repeat Testing of 25µm Hole Packages

limit that is ½ of the control limit of the most variable 25 µm package. However, by looking at the data in stages, the range for package 338 is beginning to go out of control around observation 118 (repeat #18). This point corresponds with points below the control limits on the Individual Value chart. Likewise, package 606 begins to shift its range (though still in control) around observation 78 (repeat #28). The data indicates that the variation for two of the packages is beginning to increase after roughly 20 uses.
