# Fatigue Behavior of Stringer-Floorbeam Connections

**ATLSS Report No. 91 - 07**

This paper was presented at the 8<sup>th</sup> Annual International Bridge Conference in Pittsburgh, PA.

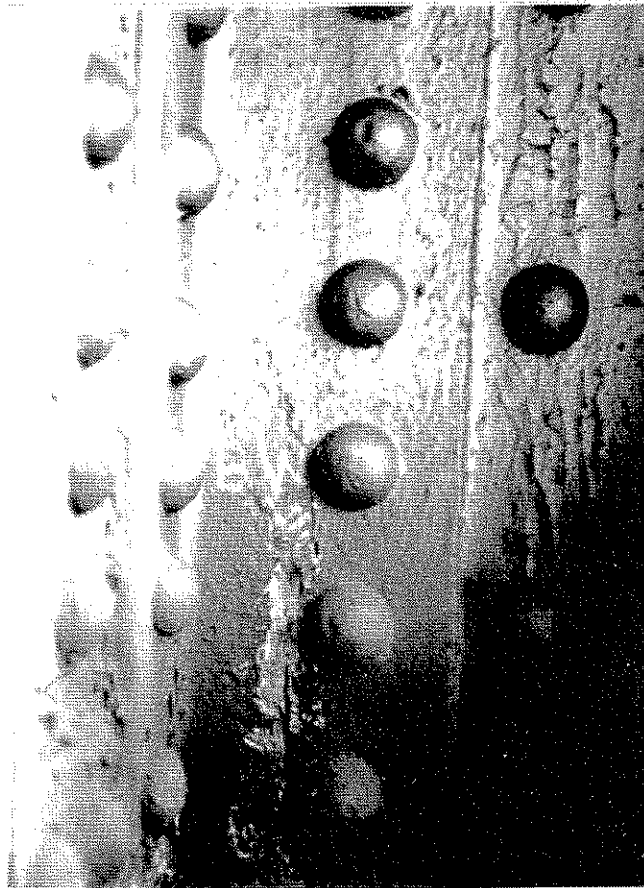
**Figure 4. Fatigue Cracked Connection Angle**

The evaluation of live load stress ranges in a connection angle, as demonstrated here, requires an elaborate analysis of the bridge structure and the connection details. Therefore the assessment of fatigue cracks such as those of Figs. 3, 4 and 5 is seldom conducted. The practical approach to alleviate fatigue problem of stringer-floorbeam connection is to establish some limits of connection angle dimensions.

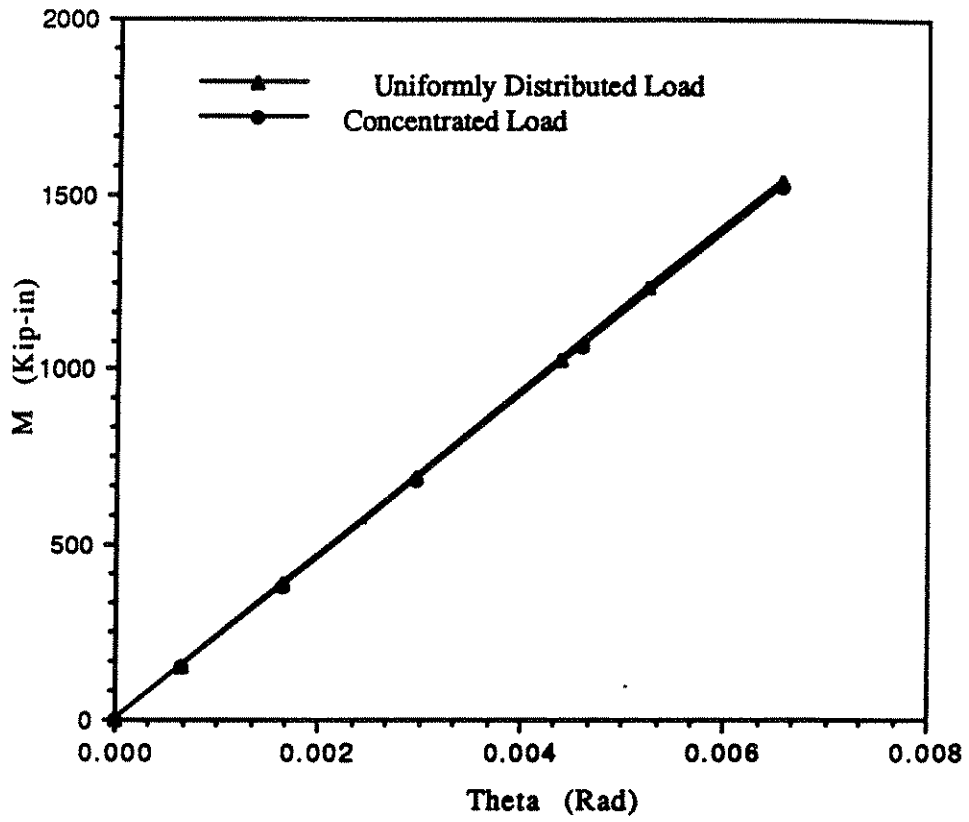
Figure 7. Moment-Rotation Relationship of A Double Angle Connection

The rotation of stringer ends and the deformation of connection angles are dependent on the floor system geometry and the dimensions of the connection angles. The rotation and deformation are interdependent. Figure 6 shows the typical rotational configuration. The more flexible the connection, the larger the rotation. On the other hand, for a specific stringer-floorbeam connection, the stringer end rotation and bending moment are practically linearly proportional. This condition is depicted in Fig. 7 for a stringer which is subjected to either a concentrated load or a uniformly distributed load.

The moment-rotation relationship of Fig. 7 is obtained through an analysis by the finite element method, which incorporates the deformation of the connection angles. The deformation shape of a connection angle corresponding to the rotational configuration of Fig. 6a is shown in Fig. 8. The corresponding principal stresses on the inside surface of the angle legs are depicted in Fig. 9. For this example, the highest tensile stress due to a HS-20 truck is about 22 ksi at the fillet at the upper end of the connection angle, without considering impact.

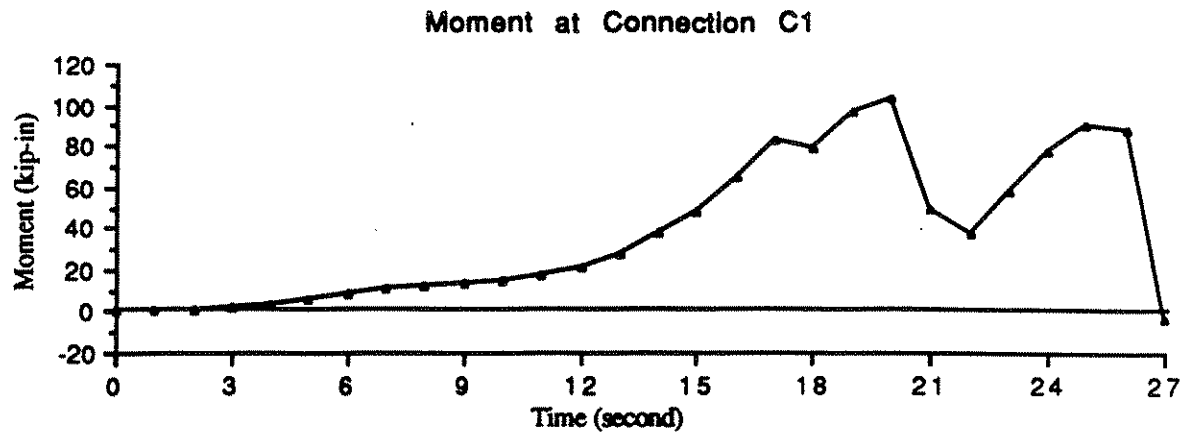
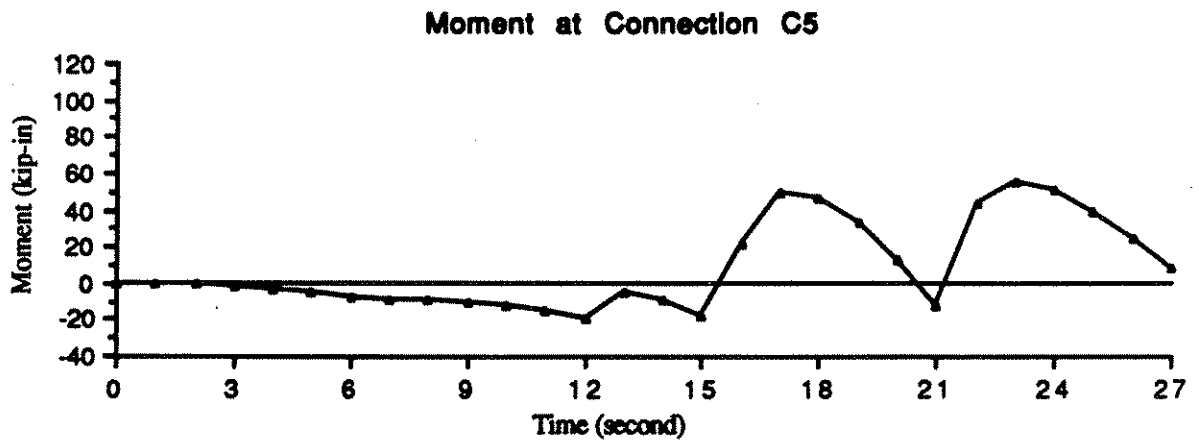
**Figure 12. Moment vs. Time Relationship for Connections, HS-20 Truck**

As a HS-20 truck travels on the bridge, the bending moment at the connection changes with time. The variation is plotted in Fig. 12 for connections C1, C3 and C5 of Fig. 10. Connections C3 and C5 are subjected to some negative bending moment, compatible with the condition that the stringers are "partially" continuous.

The stresses at all points of the connection are directly proportional to the bending moment. Thus, the curves in Fig. 12 are essentially the stress-time variation at points of the connection angles. For connection C3, the maximum live load stress corresponding to the peak moment is about 22 ksi (as shown in Fig. 9). The maximum range of stress is about 24 ksi, from -2 ksi to +22 ksi.

For connection C5 of Fig. 10 with the moment-time relationship of Fig. 12 and a corresponding maximum stress range of 24 ksi, the fatigue life of the connection is more than two million cycles when category A curve is used as reference.
