Compressive Properties of Built-up Columns

Progress Report
December 1957

AN EXPERIMENTAL INVESTIGATION OF THE
STRENGTH OF A RIVETED, BUILT-UP COLUMN

Fritz Laboratory Report No. 249.3

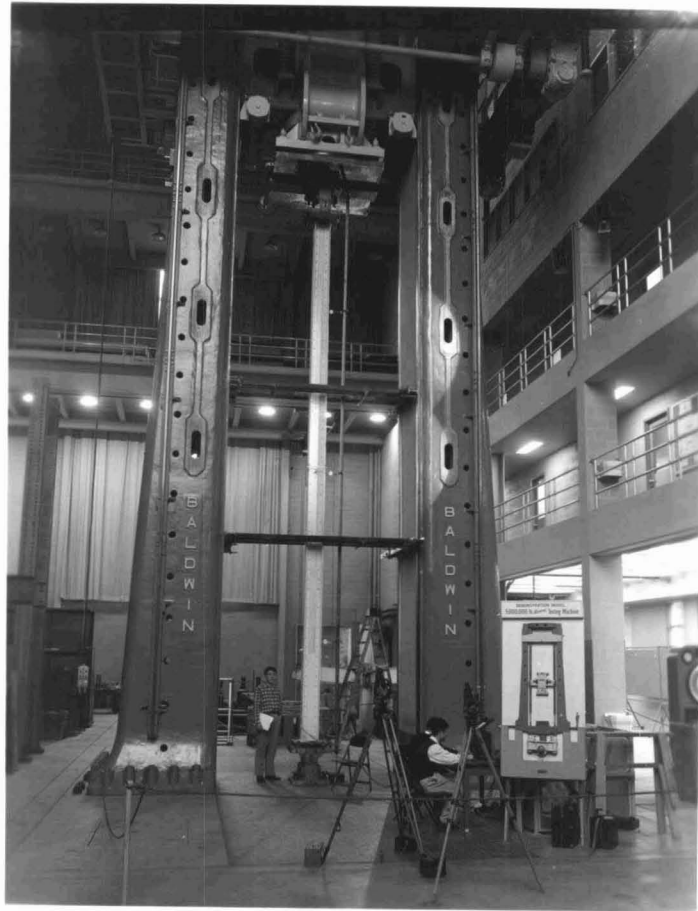
FIG. 4 R-III COLUMN TEST IN PROGRESS

The column investigated was allowed to bend in its strong direction due to pin-ended conditions. It was, however, restrained at two locations by a bracing system to prevent buckling in the "weak" direction. The loading was a concentric, axial, compressive thrust. The machine used was an hydraulic type universal testing machine of 5,000,000 lbs. capacity.

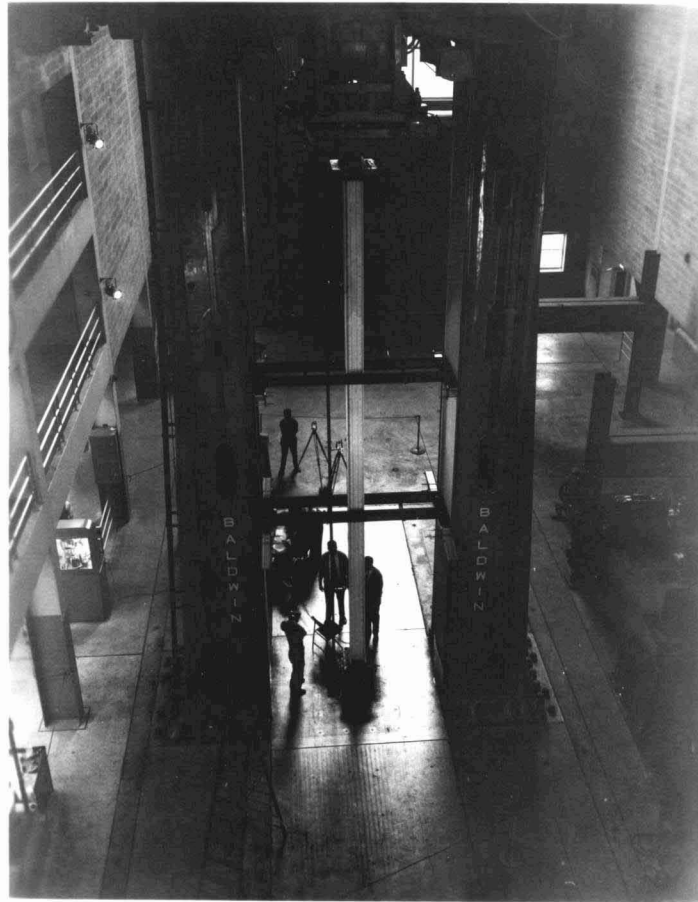
FIG. 5 A VIEW OF THE LATERAL SUPPORTS

Since the slenderness ratios of the total length column in the two directions were markedly different, it was necessary to prevent bending in the weak direction, as was pointed out earlier. On investigation it was determined that one lateral support at the mid-height of the column would just be sufficient to prevent the column from failing in the weak direction. However, two lateral supports were used for reasons of safety, and to ensure the desired failure type. In Fig. 4 the bracing system is shown. This system consisted of two brackets 8 ft. apart and 10 ft. from both ends which were attached after the alignment was completed.

The deflections were measured by the following means: 1) 1/100" scales attached to the column were read by a transit fixed in position; and 2) Deflections were also obtained from three 1/10,000" dial gages of 2" range. These were located at the center section of the column and at sections 5 ft. from the ends. The gages were attached to a vertical rod suspended from the cross head of the machine which was guided at the bottom to move only vertically. This can also be seen in Fig. 5
