# Assessment of Impact Damage in Fully Adhered Commercial Roofing System

A Dissertation

Mechanical Engineering

Numerical and Experimental Investigation of Impact Damage in Fully Adhered Commercial Roofing Systems

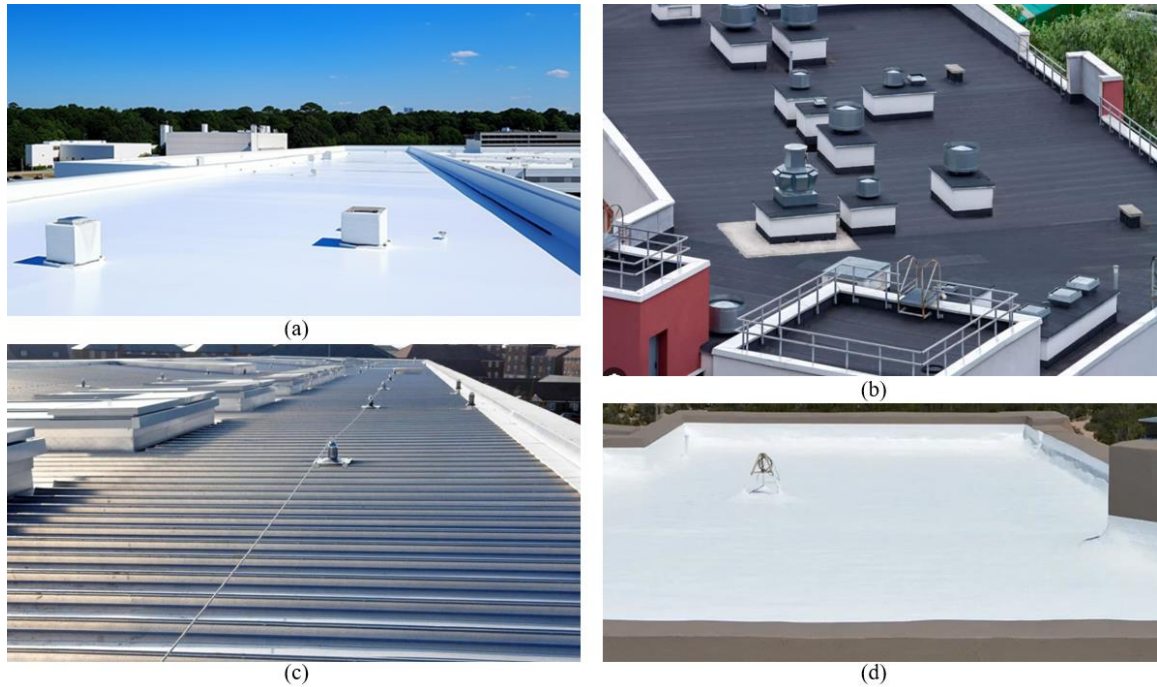
Figure 1 Commercial Roofing Systems

(a) Single-ply membrane [4]; (b) Build-up [5];  
(c) Metal [6]; (d) Spray polyurethane foam [7].

Commercial roofing systems can generally be classified into six main categories: single-ply membrane roofing, built-up roofing, modified bitumen roofing, metal roofing, spray polyurethane foam (SPF) roofing, and green roofing systems [1]. Among these, single-ply membrane roofing dominates the US market, accounting for approximately 29.4% of the regional market valued at USD 11.9 billion in 2023, and is expected to grow at a compound annual growth rate (CAGR) of 6.4% over the next several years [2] [3]. This type of roofing system is favored due to its ease of installation, high energy efficiency, long-term durability, and cost-effectiveness over the entire life cycle.

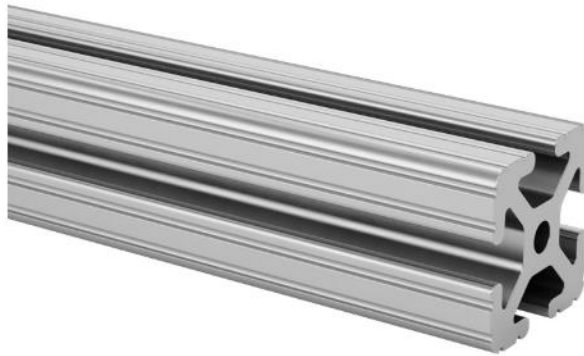
Figure 7 T-slotted Aluminum Rail [27]

The drop tower is a self-standing apparatus designed to release steel impactors from adjustable heights (Figure 6). It consists of a frame system constructed from anodized T-slotted aluminum rails (hereafter referred to as aluminum rails or simply rails, see Figure 7) built on top of a H-beam steel base. The base is a 77-inch-long segment of W12 × 190 capped at both ends with steel plates. On each flange of the H-beam, two rows of holes were drilled to mount short horizontal aluminum rails that serve as the base anchors for the frame structure. Three 10-foot-long aluminum rails (main columns) were mounted vertically onto the horizontal rails—two at the front side, one at the back. Their mounting

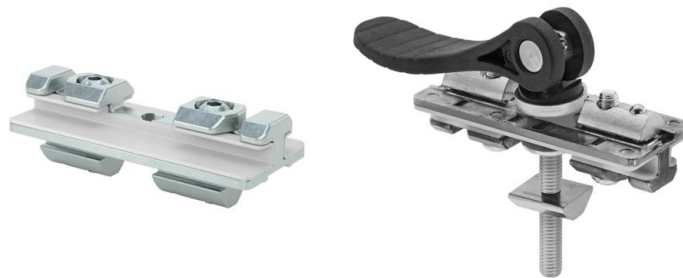
Figure 9 Rail slide and slide with cam handle [28] [29]

Between the two front main columns, a sliding mechanism was assembled using aluminum rails arranged perpendicularly with each other to form a C-shaped frame (Figure 8). The open side of the “C” faces downward, allowing the two vertical members to be connected to the main columns through rail slides (Figure 9). Another piece of aluminum rail, vertically aligned on the back side of the drop tower, serves as the rear slider (Figure 10). This rear slider is also connected to the rear main column via three rail slides. These rail slides are equally spaced, with the one in the middle being a special rail slide with a

cam handle (Figure 9). To facilitate manual repositioning, a bolt is installed horizontally near the bottom end of the rear slider. This bolt is oriented perpendicular to the rear slider and functions as a pull handle. A pull rope is tied to the bolt, allowing the operator to lower the rear slider by pulling on it when the rear slider is in its uppermost position and the pull handle is out of reach (Figure 10).

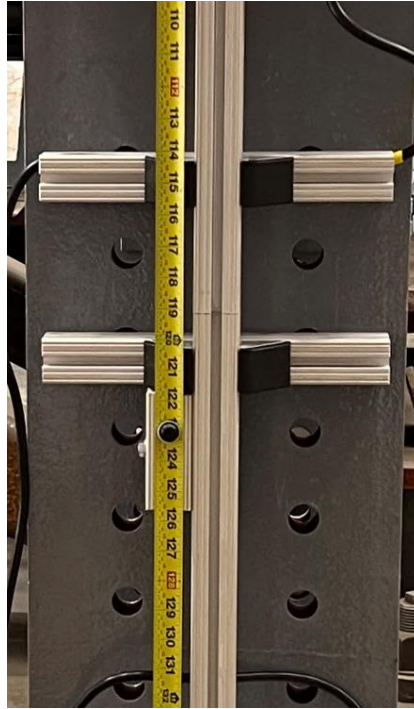
Figure 11 Drop height scale

To assist with accurate drop height adjustment, a cut segment of tape measure was mounted vertically alongside the rear slider (Figure 11) as a height scale. This scale allows the operator to determine the current height of the impactor relative to the base of the tower, based on the vertical position of the rear slider. The position of height scale can be adjusted to accommodate the variation of the thickness of the sample to be tested. It provides a quick and reliable visual reference for setting specific drop heights required by different test standards.

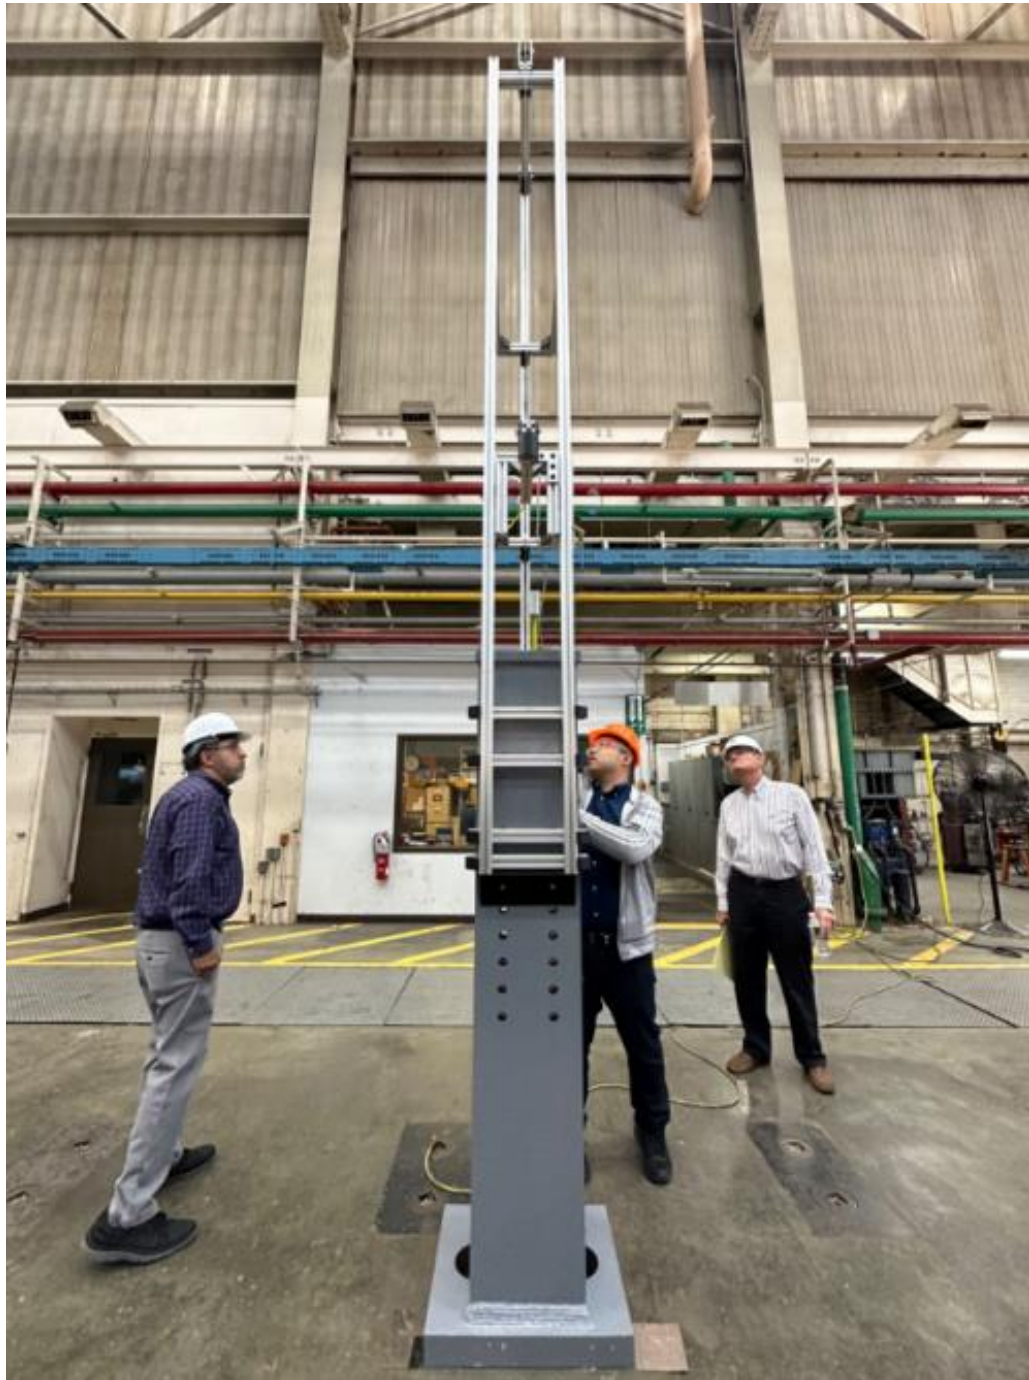
Figure 12 The drop tower ready for its first test

In accordance with the requirements of the research sponsor and collaborator, the drop tower was designed as a stand-alone structure, rather than an attachment to an existing wall or building. The tower was initially assembled and precisely adjusted in the Large Structures Laboratory of the ATLSS Engineering Research Center at Lehigh University's

Mountain Top Campus. Following the completion of impact testing at Lehigh, the drop tower was shipped to a testing facility of the sponsor, where it continues to serve as an efficient testing equipment.

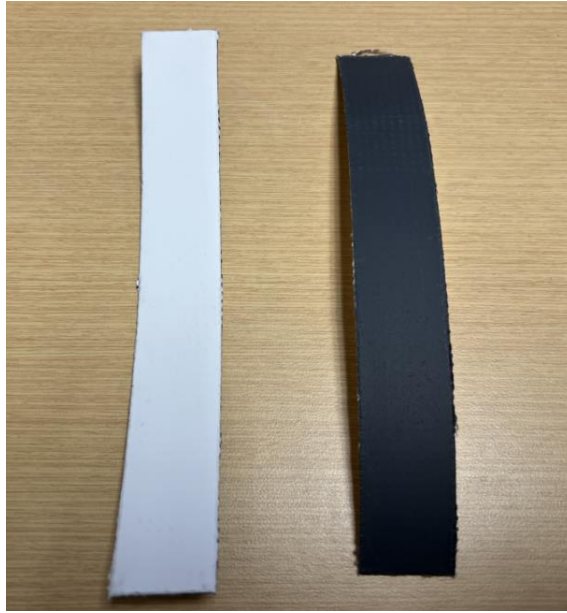
Figure 14 Samples of TPO membrane [32]

The TPO membrane can be regarded as a three-layer component. The matrix material with the white color is referred to as the cap, for it's the topmost layer of the roofing system to resist environmental elements such as sunlight and rain. The matrix material on the other side of the TPO membrane is referred to as the core. Between these two layers is a polyester scrim reinforcement, which provides dimensional stability and resistance to tearing [31]. Commercially available TPO membranes typically range from 45 mil to 80 mil in thickness. In this research, a 60 mil TPO membrane was used.

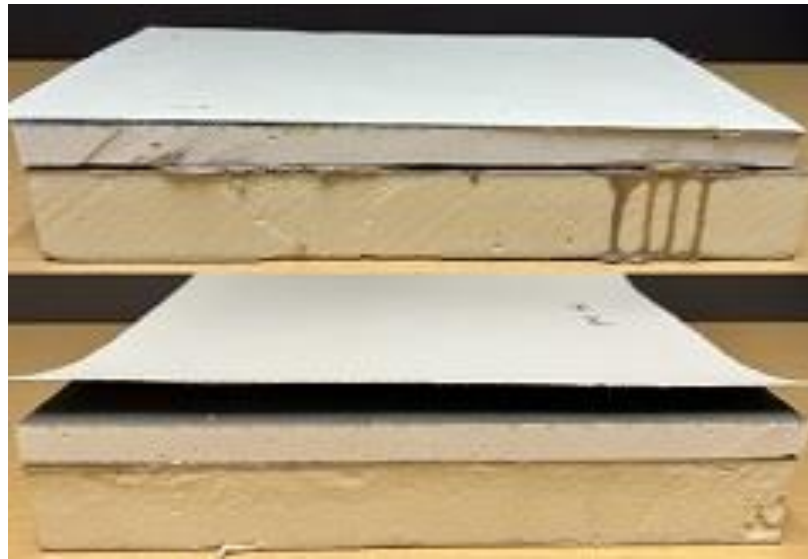
Figure 18 Fully-adhered (top) and non-adhered samples (bottom)

The non-adhered samples, in the absence of any interlaminar bonding, were included to enable direct assessment of isolated damage on surfaces of each component layer. All samples had a footprint of  $10 \times 10$  in. Note that for the impact tests conducted, no structural roofing decks (like the corrugated steel deck shown in Figure 13) were included.

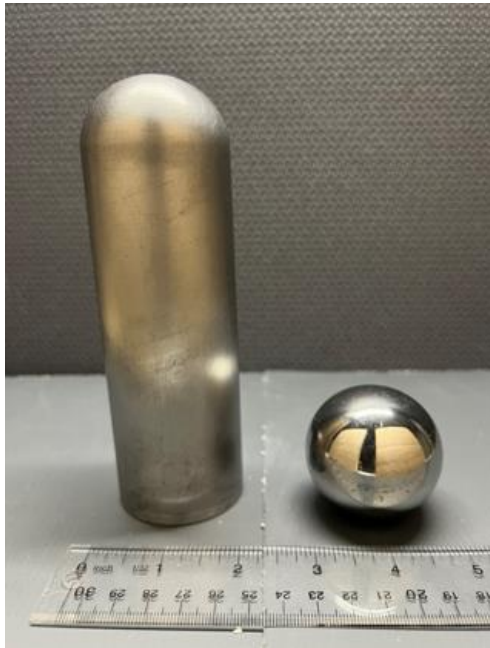
Figure 19 Steel dart and steel ball

| | MH | SH | VSH | Drop Tower | |
|---|---|---|---|---|---|
| Drop Height<br>(in.) | 81 | 141.5 | Launcher | 74.8~157.5 | 1.36~3.34 |
| Impact Energy<br>(ft · lbf) | 8 | 14 | 53-58 | 7.4~15.5 | 24.3~59.7 |
