FRACTURES OF BEAM-TO-COLUMN WEB
MOMENT CONNECTIONS

George C. Driscoll

Fritz Engineering Laboratory
Lehigh University
Bethlehem, Pennsylvania

March 1979

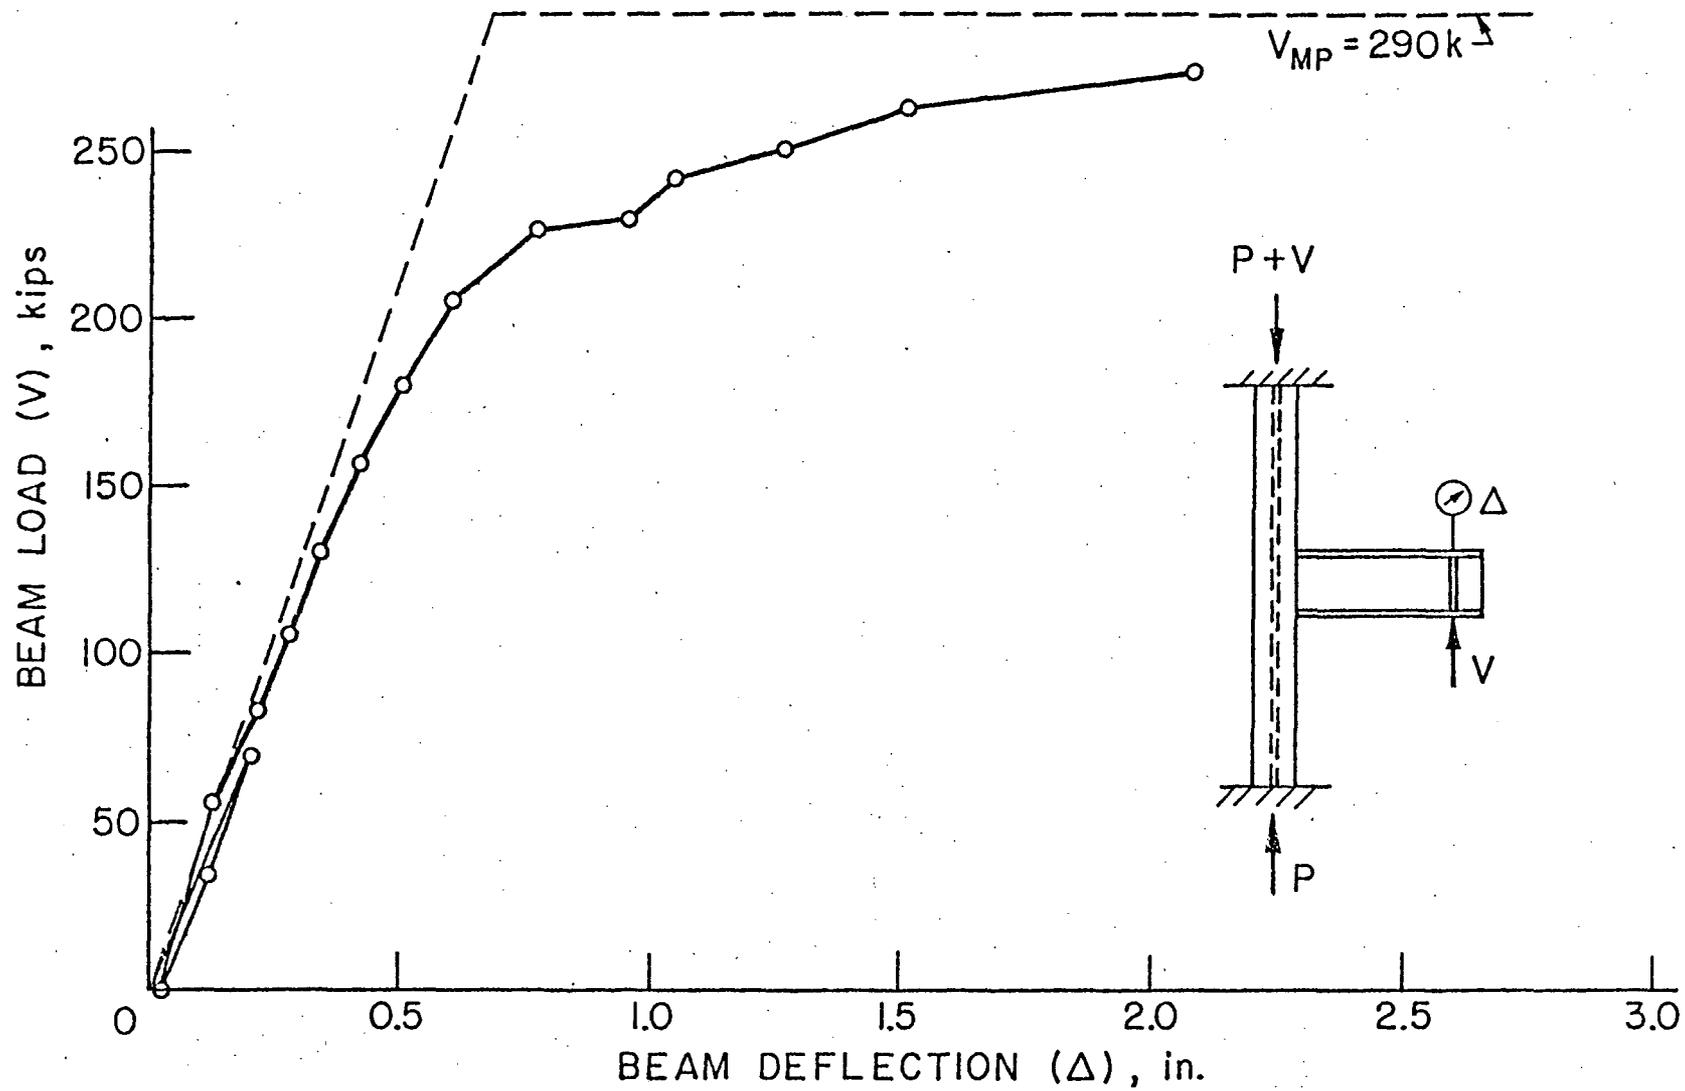
Fig. 2 Load-Deflection Curve of Test 14-1

The load-deflection curve of this specimen is given in Fig. 2. Photographs after test are given in Fig. 8 and 9 of the preprint and pertinent statistics are given in Table 1 of the preprint.

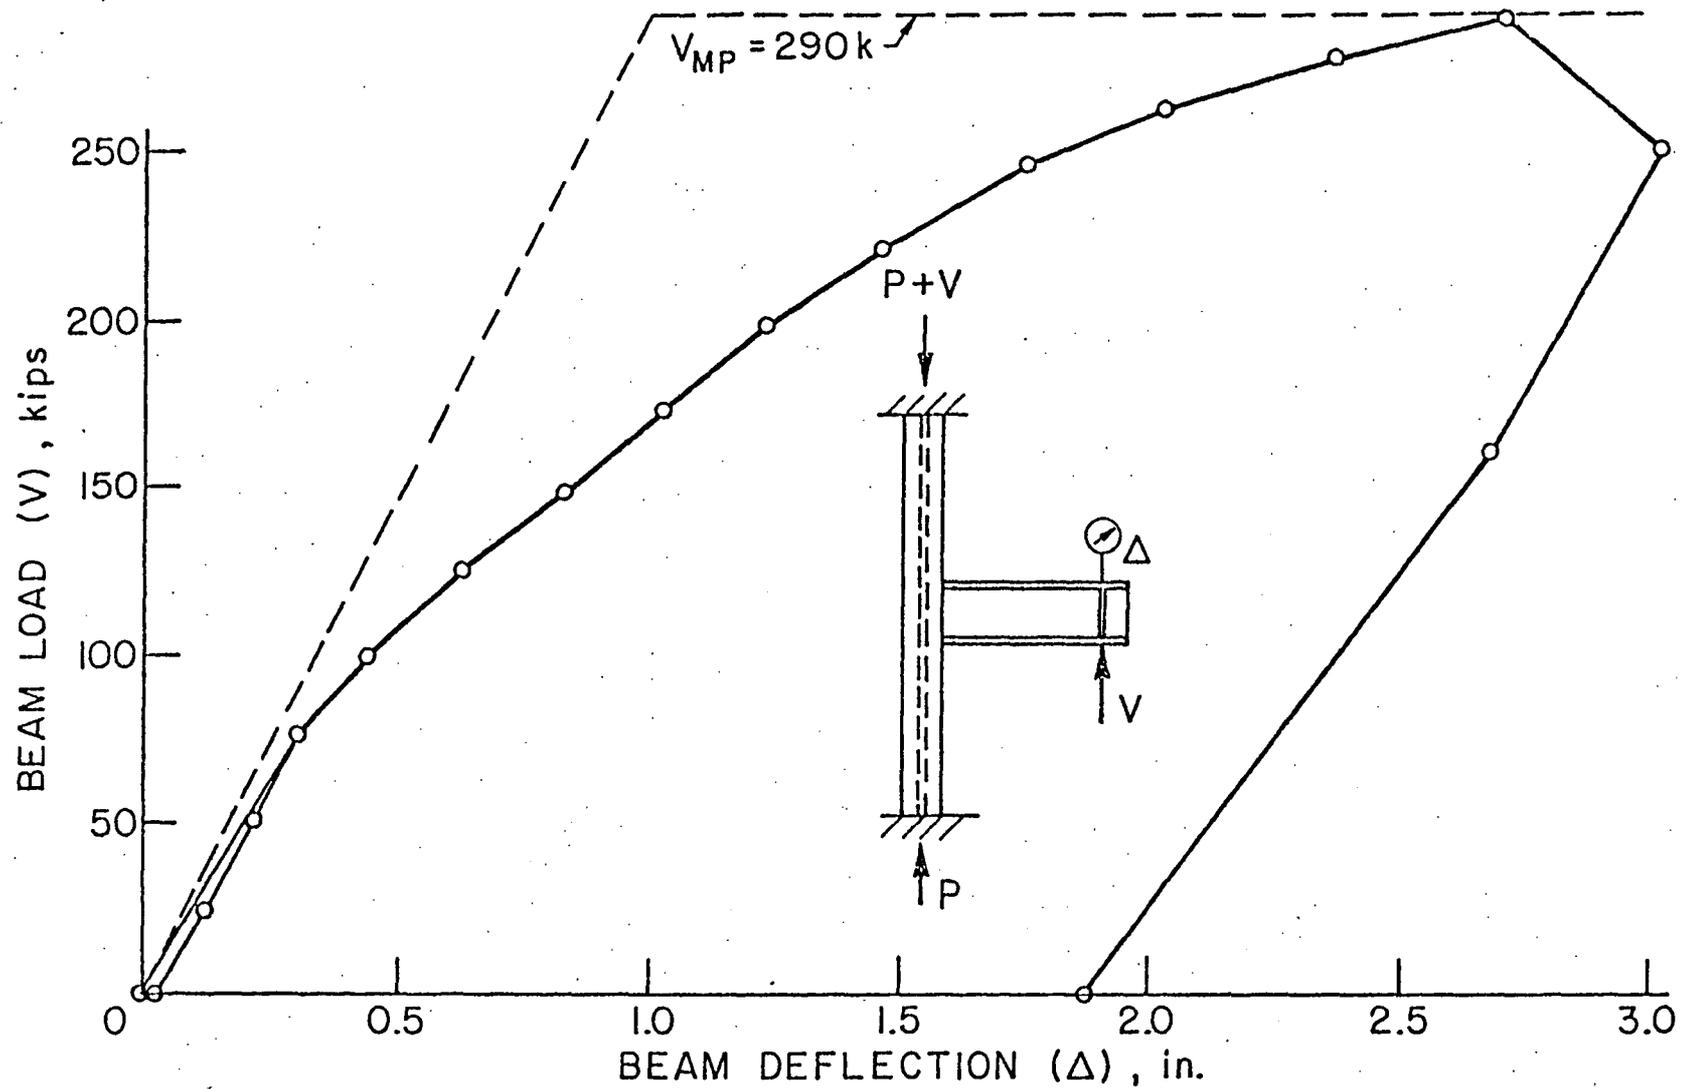
Fig. 5 Load-Deflection Curve of Test 14-3

The load-deflection curve of this specimen is given in Fig. 5. The initial slope of the experimental curve shows fair agreement with the slope of an idealized theoretical curve considering linear effects of bending, shear, and axial deformation.
