# Historical Evolution of Design and Supply of Drinking Water Treatment Plant for the City of Bethlehem, 1741-Present

**Dr. Arup SenGupta**  
**CEE 377: Environmental Engineering Design**  
**Department of Civil and Environmental Engineering Lehigh University**

## **Executive Summary**

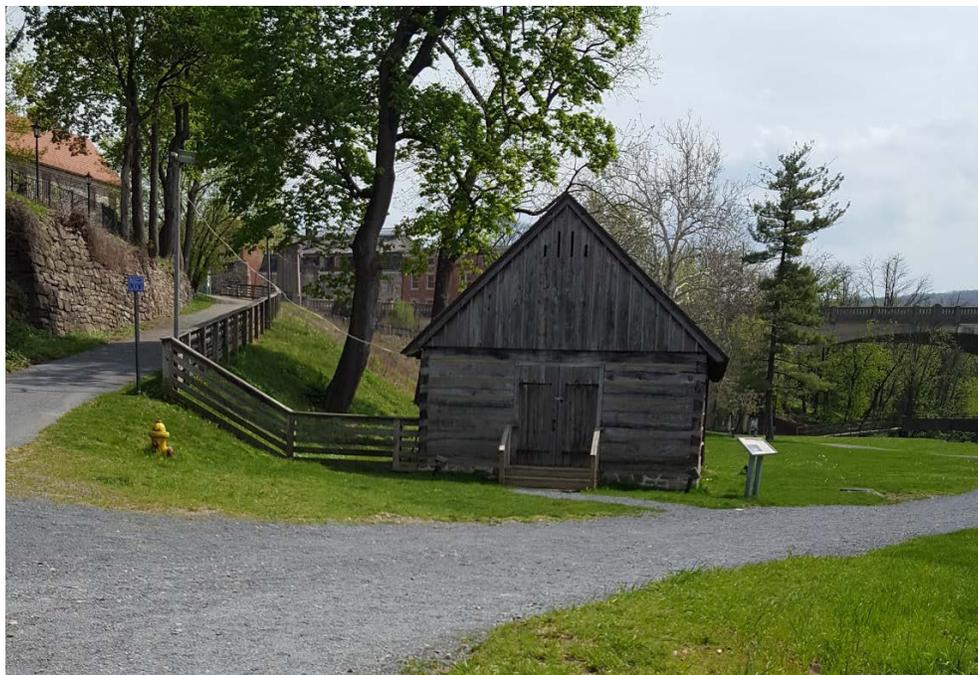
**Figure 1: Representation of 1754 Frame Springhouse**

In 1751, a millwright named Hans Christiansen arrived in Bethlehem with “rare mechanical abilities.” He realized that the water wheel in the bark crushing mill could be used to pump water up to the village. This realization eventually led to the erection of the first pumping equipment used for municipal water supply in the 13 colonies. For this significance, the Bethlehem waterworks are now a National Historic Civil Engineering Landmark, a National Historic Landmark and an American Water Landmark (Hein 2016). Construction of the pumping system started in the spring of 1754 with the erection of a 78 ft water tower where the central Moravian church now stands. Another tank was built in front of the girls’ school and a 19 ft by 22 ft frame was built over the spring to enclose the machinery (Green 1933). Figure 1 shows the

structure that is currently on top of the spring. While the spring does not come to the surface today, this is a representation of what the frame would have looked like in 1754.

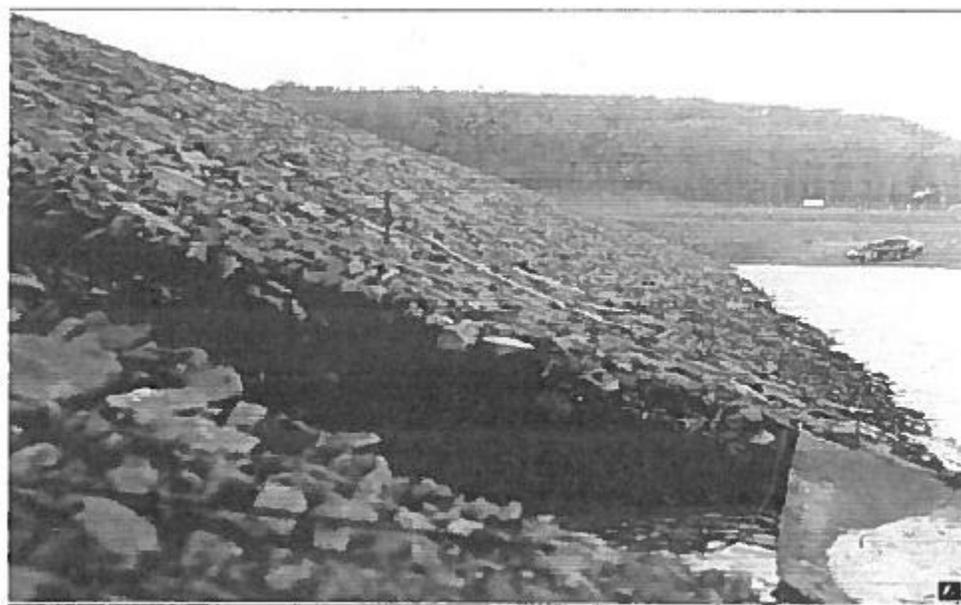
**Figure 5: Sinkhole, May 1960 (Schwinger et al. 1999)**

developed on the upstream embankment slope approximately 4.5 ft below the spillway height. The sinkhole was recorded to be approximately 15 ft in diameter and 15 ft deep. A dam that was designed to last 100 years failed in one month (Assad 1998). The sinkhole is pictured in Figure 5. In order to mitigate the leakage the sinkhole was filled with approximately 100 cubic yds of silt and shale. However, this filling had little to no measurable reduction on the leak. Next, the water elevation was lowered by another 26 ft below the spillway crest to decrease the head of the water in the hopes of eliminating the leak. As a result of the lowered head, the recorded leakage decreased from the initial 350 gallons per minute to 90 gallons per minute (Assad 1998).

*Sinkhole, May 1960*

Initial repairs included grouting of the underlying foundation rock in the vicinity of the sinkhole and pressure injecting surface-hydrated bentonite lumps and cellophane strips in the embankment to fill the voids (Schweiger et al. 1999). During drilling for grouting, engineers discovered voids in the embankment up to 18 in diameter. The foundation rock was grouted with cement in a 1:1 ratio by volume (Bingham et al. 1999). Upon completion of the grouting program seepage from the road cut alone was recorded to be 20 gallons per minute at a water
